BMW 3: 1HUP165

Limited Technical Inspection

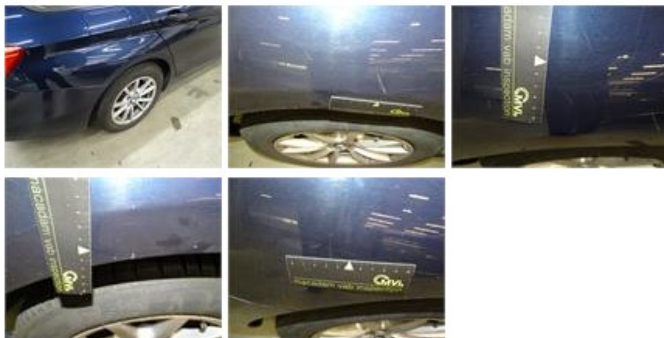
Wing R R, Scratch(es), LI - Repair and paint (complete) 308,20

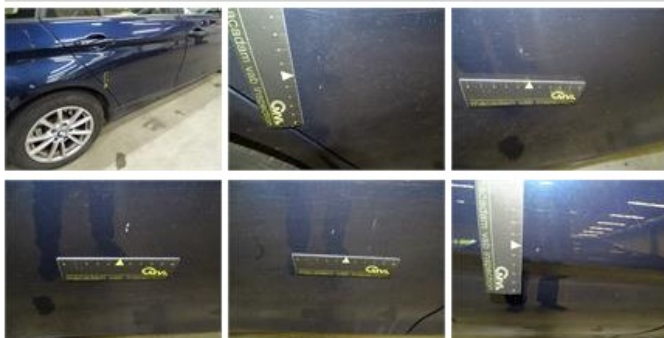
Door R R, Scratch(es), LI - Repair and paint (complete) 318,35
