**VOLVO XC60: 1LNB510**

**Limited Technical Inspection**

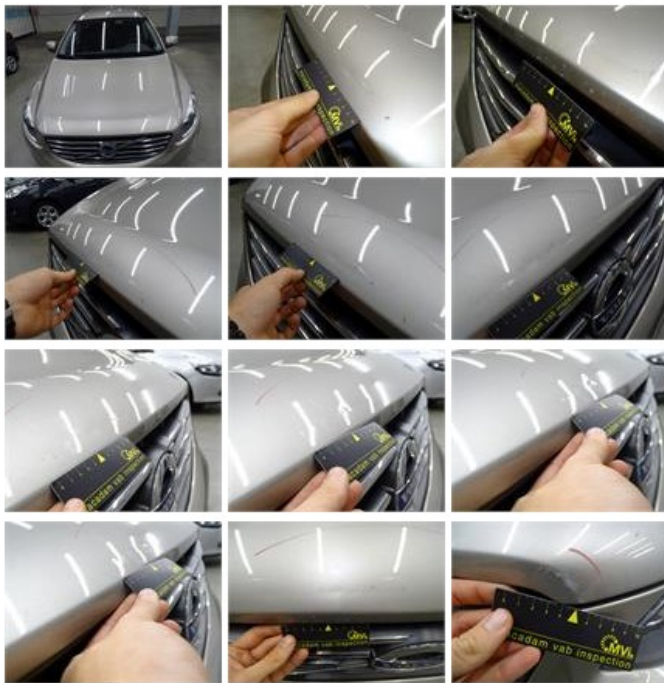
<b>Total cost ex VAT</b>	<b>1067,09</b>
<b>Bonnet, Dent(s) and scratch(es), LI - Repair and paint (complete)</b>	<b>348,09</b>

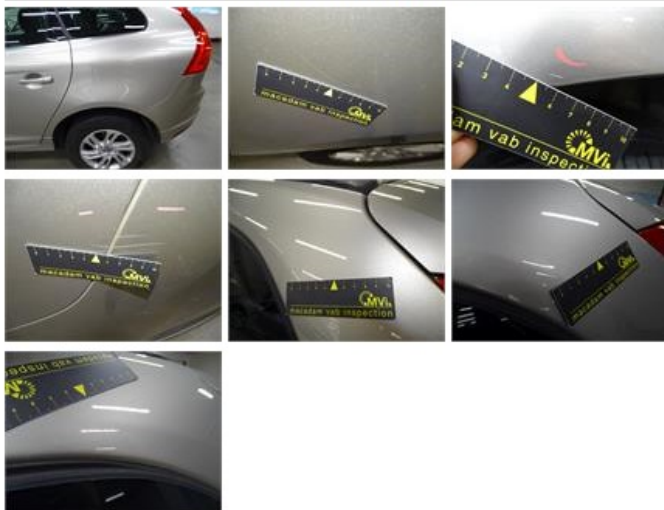
Tailgate, Scratch(es), 67 - Polish	0,00
<i>No pictures to display</i>	
Door F L, Chemical polution, 67 - Polish	0,00
<i>No pictures to display</i>	
Bumper F, Scratch(es), Acceptable	0,00
<i>No pictures to display</i>	
Wing R L, Scratch(es), LI - Repair and paint (complete)	369,84

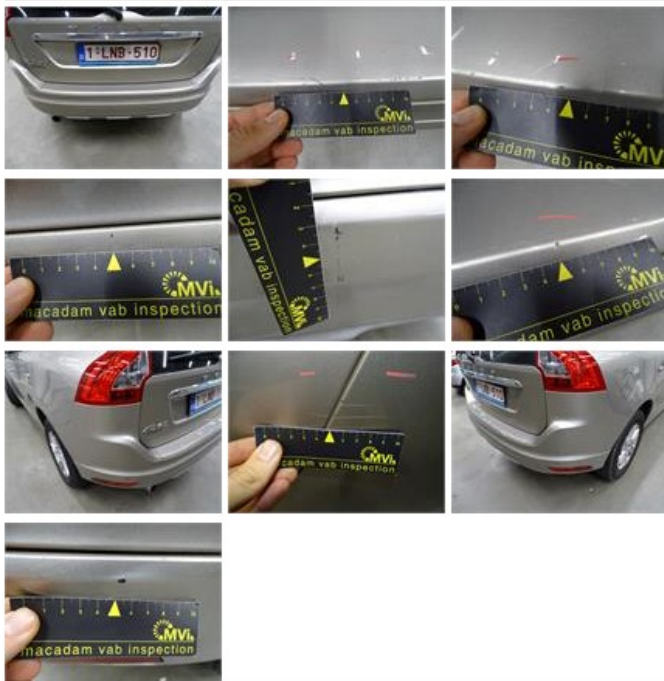
Bumper R, Scratch(es), LI - Repair and paint (complete)	254,16
---	--------

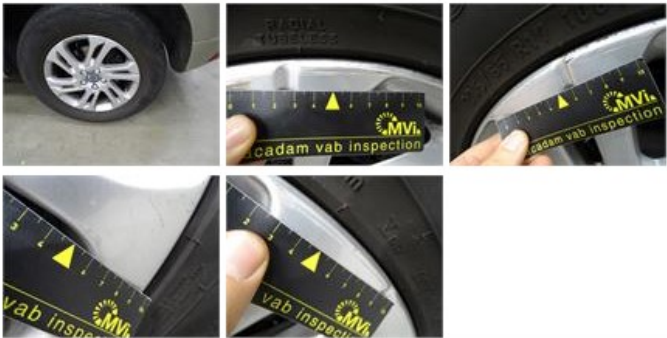
<i>No pictures to display</i>		
Wing F L, Scratch(es), Acceptable		0,00
<i>No pictures to display</i>		
Alloy rim R R, Scratch(es), Acceptable		0,00
<i>No pictures to display</i>		
Door R L, Scratch(es), Acceptable		0,00
<i>No pictures to display</i>		
Door R R, Scratch(es), Acceptable		0,00
<i>No pictures to display</i>		
Alloy rim R L, Scratch(es), LI - Repair and paint (complete)		95,00
