## VOLVO V60: 1HLZ139

## Limited Technical Inspection

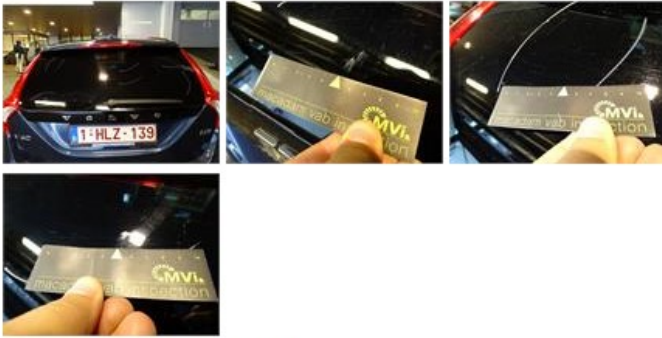
Total cost ex VAT	465,00
Rear window, Scratch(es), E - Replace	370,00
