AUDI A3: 1LLJ315

Limited Technical Inspection

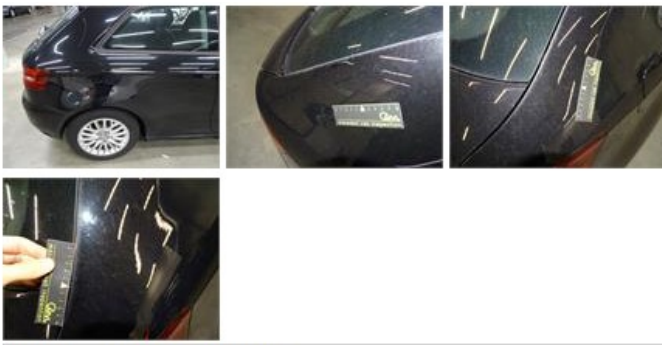
Total cost ex VAT	1238,38
Wing R R, Scratch(es), LI - Repair and paint (complete)	308,20

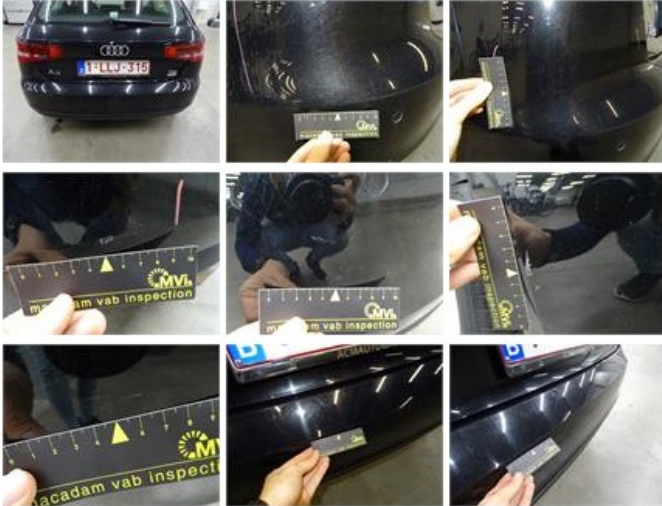
Bumper R, Scratch(es), LI - Repair and paint (complete) 211,80

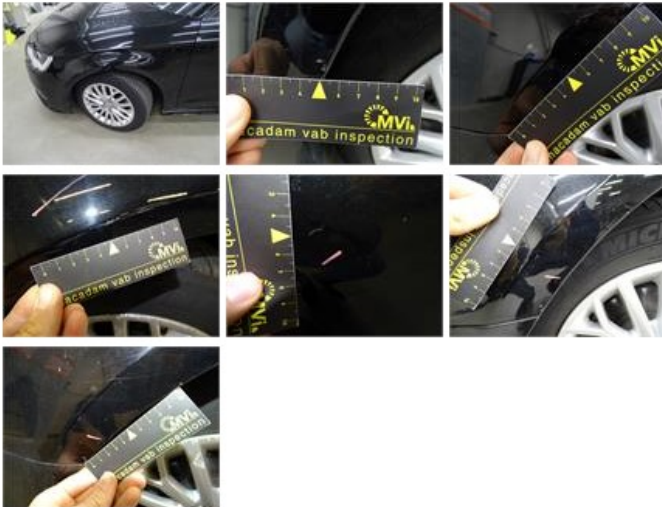
Wing F L, Scratch(es), LI - Repair and paint (complete) 220,18

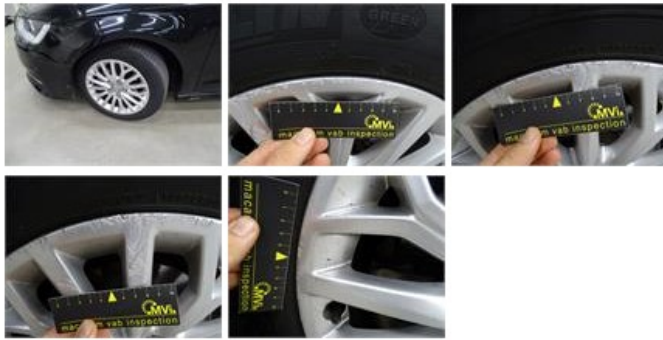
Alloy rim F L, Scratch(es), LI - Repair and paint (complete)

95,00

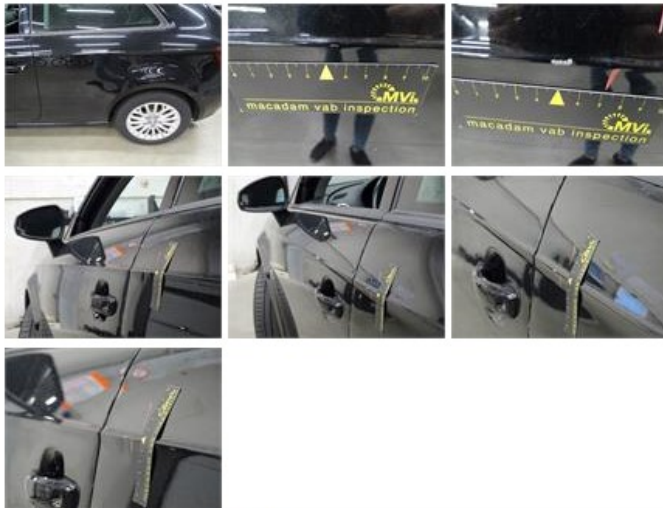
Wing R L, Dent(s) and scratch(es), LI - Repair and paint (complete)

308,20
