AUDI A5 SPORTBACK: 1JTJ697

Limited Technical Inspection

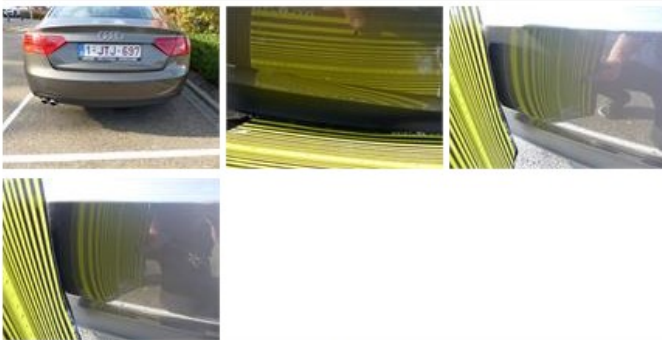
Bumper R, Dent(s), LI - Repair and paint (complete) 302,16

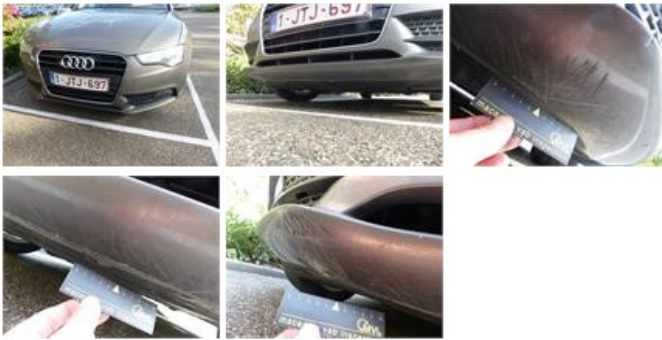
Bumper F, Scratch(es), LI - Repair and paint (complete)

254,16
