**BMW 1 HATCH: 1KCL169**

**Limited Technical Inspection**

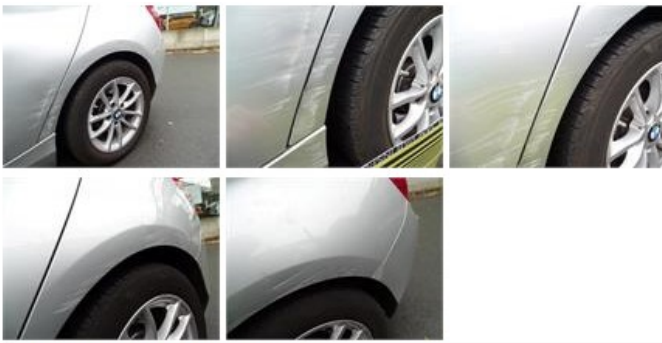
Sill outer L, Scratch(es), It - Spot repair 115,56

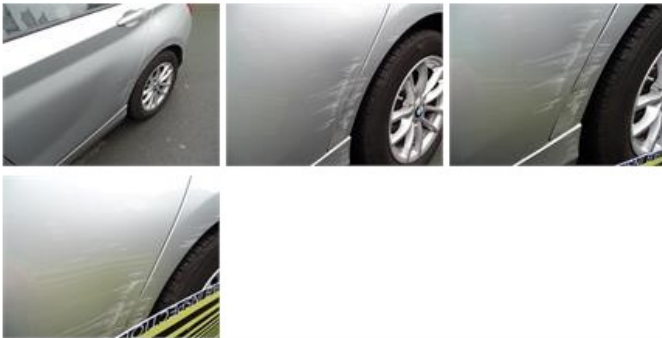
Door R L, Dent(s) and scratch(es), LI - Repair and paint (complete) 414,35

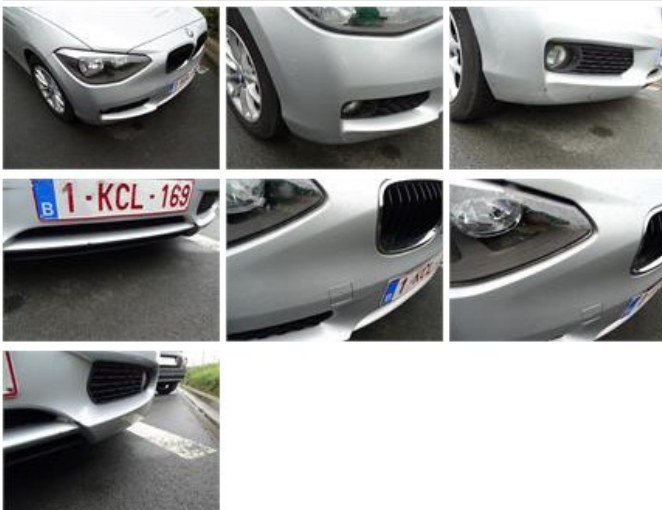
Bumper F, Dent(s) and scratch(es), LI - Repair and paint (complete) 259,80

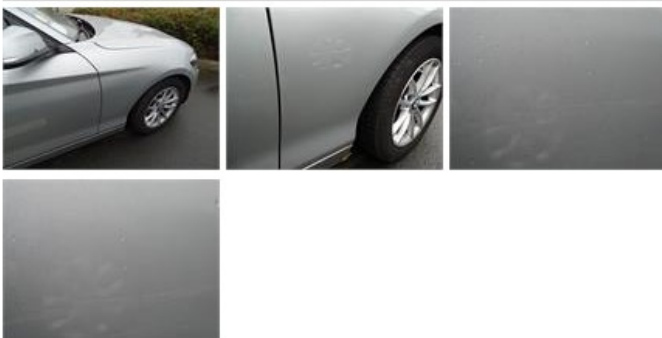
Wing F R, Scratch(es), LI - Repair and paint (complete) 220,18

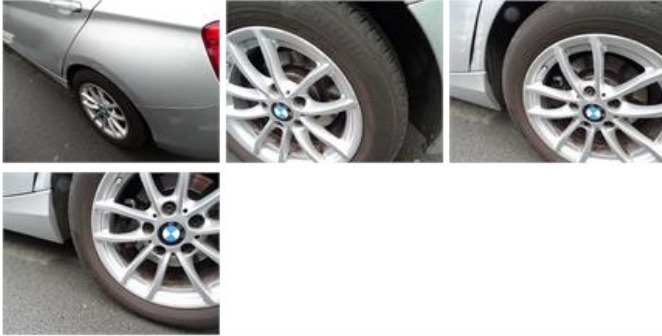
Alloy rim R L, Scratch(es), LI - Repair and paint (complete)

95,00

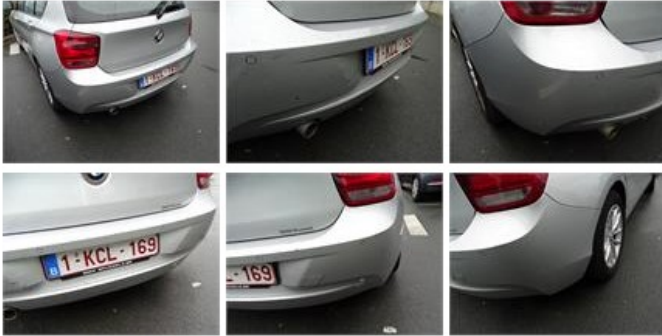
Bumper R, Scratch(es), LI - Repair and paint (complete)

211,80

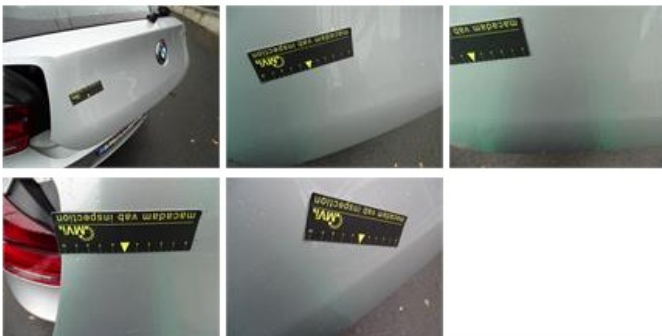
Tailgate, Scratch(es), LI - Repair and paint (complete)

301,68

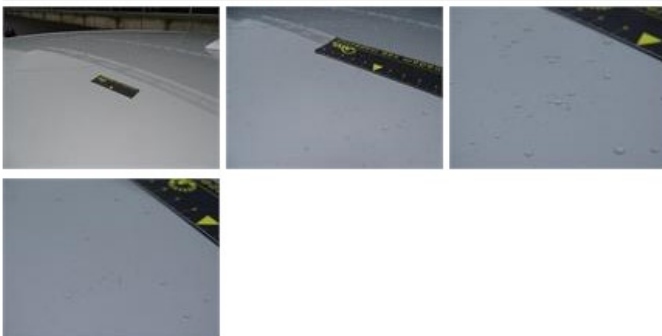
Roof, Chemical pollution, LI - Repair and paint (complete)

481,50
