BMW 3 TOURING: 1LFT576

Limited Technical Inspection

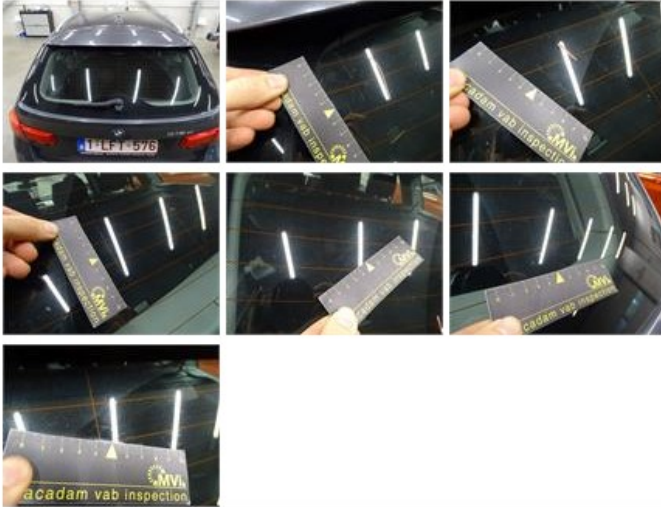
<i>No pictures to display</i>	
Alloy rim R R, Scratch(es), Acceptable	0,00
<i>No pictures to display</i>	
Door R L, Dent(s) and scratch(es), Acceptable	0,00
<i>No pictures to display</i>	
Wing R L, Scratch(es), Acceptable	0,00
<i>No pictures to display</i>	
Rear window, Scratch(es), E - Replace	0,00

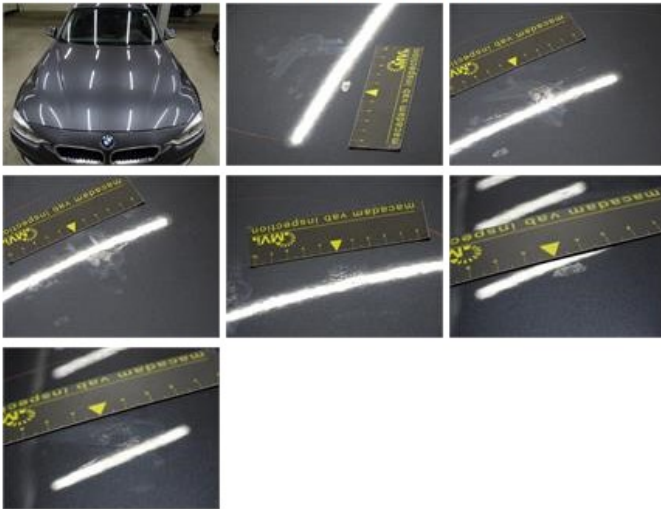
Door F R, Scratch(es), Acceptable	0,00
<i>No pictures to display</i>	
Alloy rim F L, Scratch(es), Acceptable	0,00
<i>No pictures to display</i>	
Bumper F, Scratch(es), Acceptable	0,00
<i>No pictures to display</i>	
Bonnet, Chemical polution, LI - Repair and paint (complete)	290,08

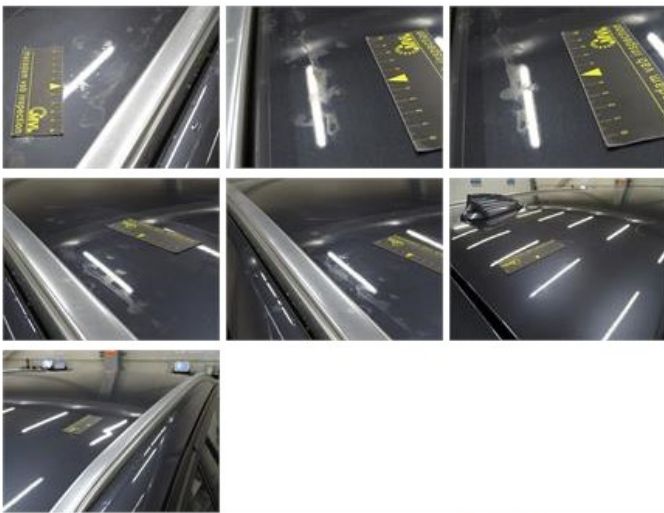
Door R R, Dent(s) and scratch(es), Acceptable	0,00
<i>No pictures to display</i>	
Door F L, Scratch(es), Acceptable	0,00
<i>No pictures to display</i>	
Roof, Chemical polution, LI - Repair and paint (complete)	481,50

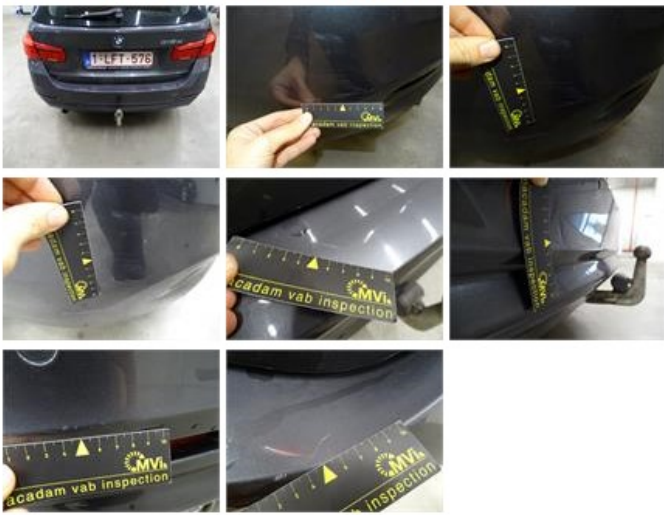
Bumper R, Dent(s) and scratch(es), LI - Repair and paint (complete)

211,80
