| BMW 3: 1HNU906 | | | |
| Vinnumber: | WBA3K11060K285297 | Versionname: | 3 TOURING 318dA 136PK Aut. |

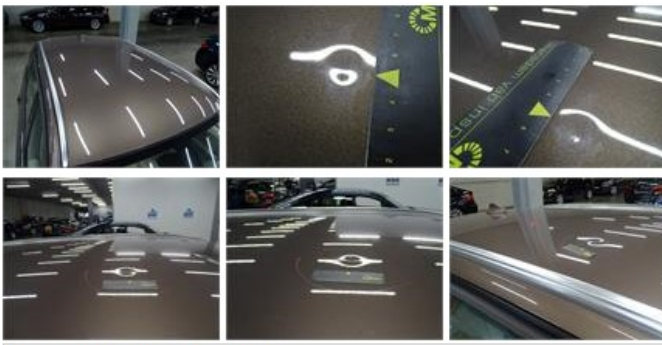
| Roof, Dent(s) and scratch(es), LI - Repair and paint (complete) | 481,50 |

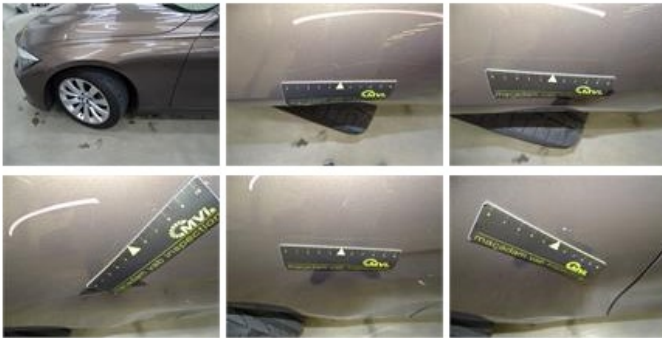
Wing F L, Scratch(es), LI - Repair and paint (complete) 220,18

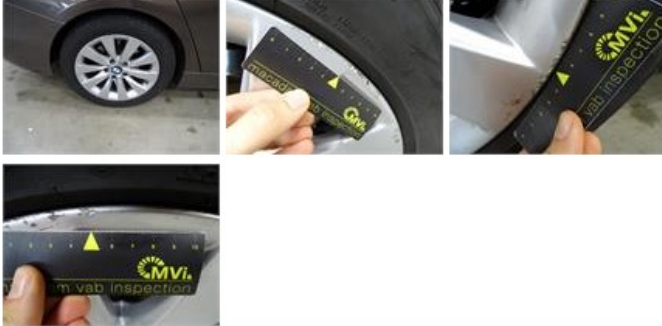
Alloy rim R R, Scratch(es), LI - Repair and paint (complete) 95,00

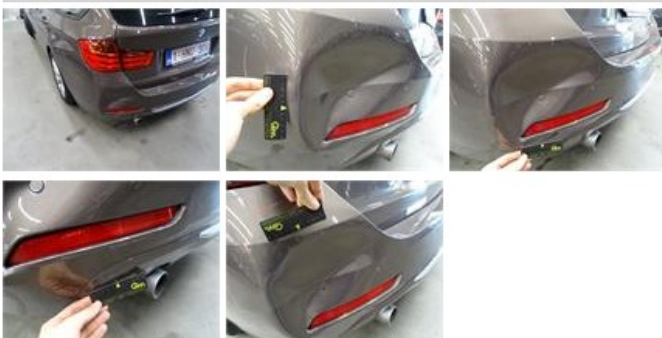
Bumper R, Deformed / Strained, Le - Replace and paint 651,00

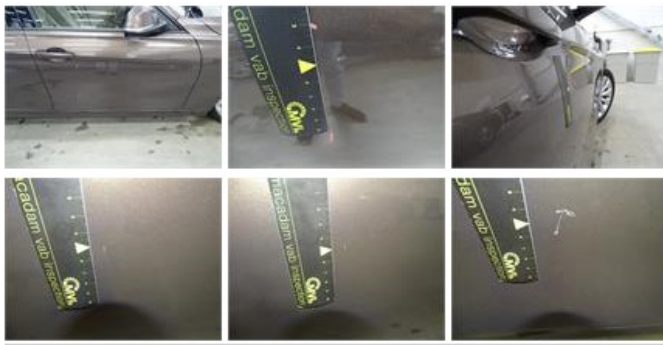
Door F R, Dent(s) and scratch(es), LI - Repair and paint (complete) 318,35

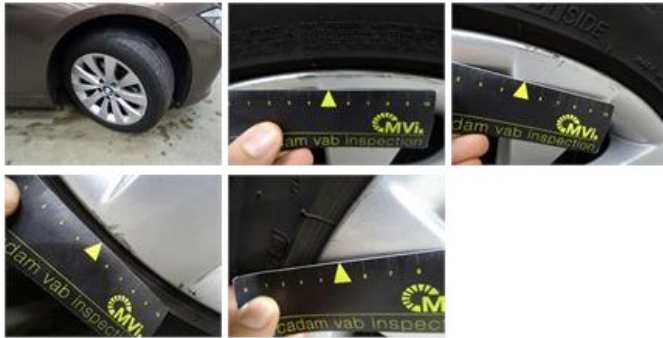
Alloy rim F R, Scratch(es), LI - Repair and paint (complete) 95,00
