BMW 3: 1HVS899

Vinnumber:	WBA3D110X0F395496	Versionname:	3 BER 318dA 136PK Aut.
First Registrationdate:	15/10/2014	Fiscalpower:	
Expertise Mileage:	69837	Power Kw:	100
Bodytype:		Body color:	Black
Gearbox:	Automatic	Paint type:	Metalic
Transmission:	Back	Rims summer:	Aluminium
Fueltype:	Diesel	Oil level:	OK
Battery functioning:	Yes	Parking lot:	2126
Number of doors:	4		
Number of seats:	5		
Number head rests:	5		
Rims summer:	Aluminium		
Category:	Passenger Car		
Oil level:	OK		
Registration Certificate Car (BE):	Yes

Limited Technical Inspection

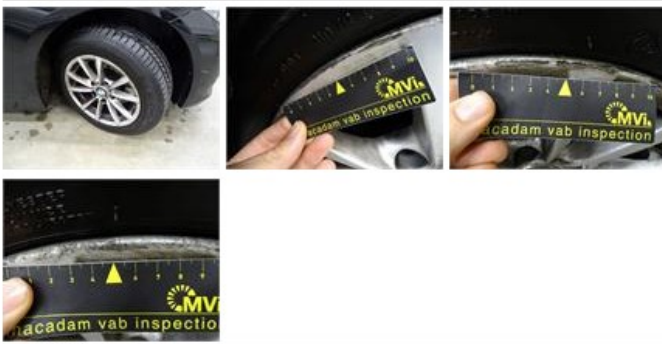
Alloy rim F R, Scratch(es), LI - Repair and paint (complete)	95,00
---	--------------

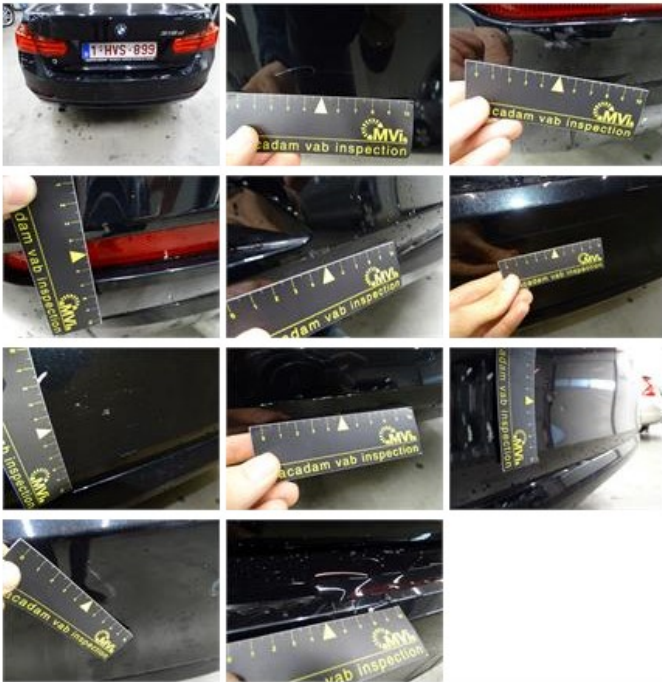
Bumper R, Dent(s) and scratch(es), LI - Repair and paint (complete) 211,80

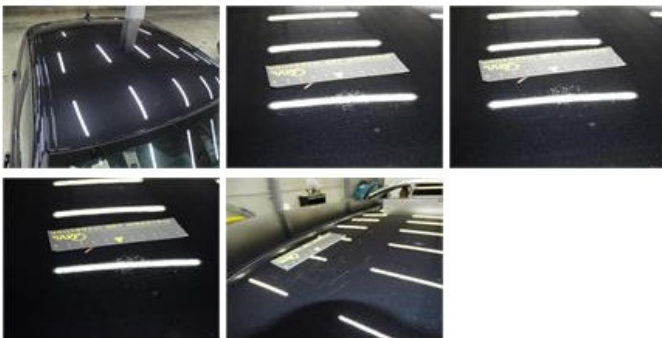
Roof, Chemical polution, LI - Repair and paint (complete) 481,50

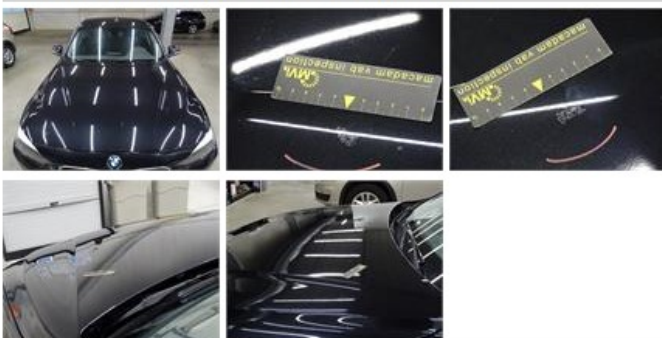
Bonnet, Chemical polution, LI - Repair and paint (complete) 290,08

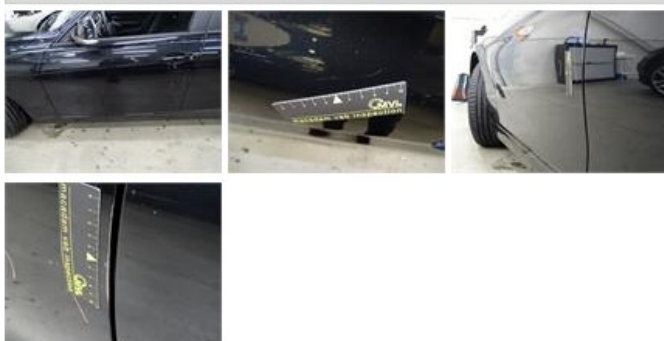
Wing R L, Dent(s) and scratch(es), LI - Repair and paint (complete)
