**BMW 3 BERLINE: 1PBY936**

**Limited Technical Inspection**

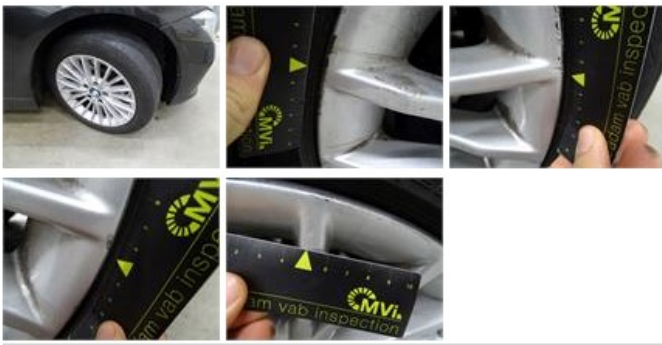
<b>Alloy rim F R, Scratch(es), LI - Repair and paint (complete)</b>	<b>95,00</b>
---	--------------

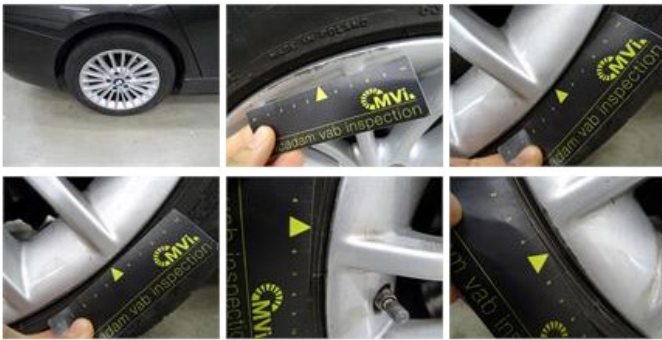
Roof, Chemical polution, 67 - Polish	0,00
<i>No pictures to display</i>	
Alloy rim R L, Scratch(es), Acceptable	0,00
<i>No pictures to display</i>	
Bumper F, Scratch(es), Acceptable	0,00
<i>No pictures to display</i>	
Door F R, Scratch(es), Acceptable	0,00
<i>No pictures to display</i>	
Bonnet, Chemical polution, 67 - Polish	0,00
<i>No pictures to display</i>	
Door R R, Dent(s) and scratch(es), Acceptable	0,00
<i>No pictures to display</i>	
Alloy rim R R, Scratch(es), LI - Repair and paint (complete)	95,00

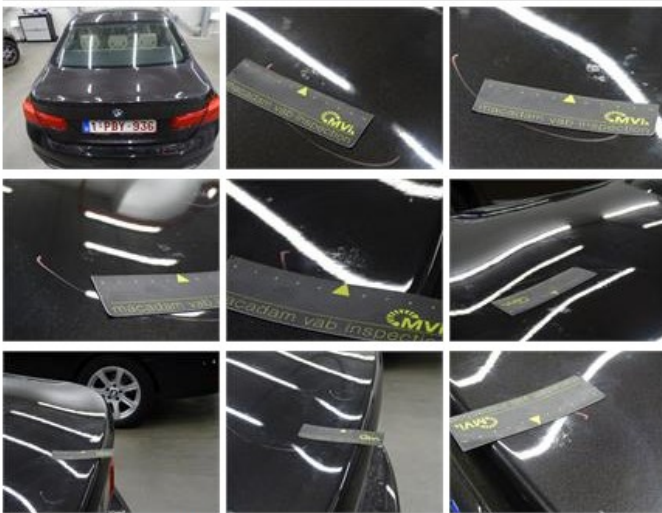
Tailgate, Chemical polution, LI - Repair and paint (complete)	301,68
---	--------
