BMW 3: 1GAI318

Limited Technical Inspection

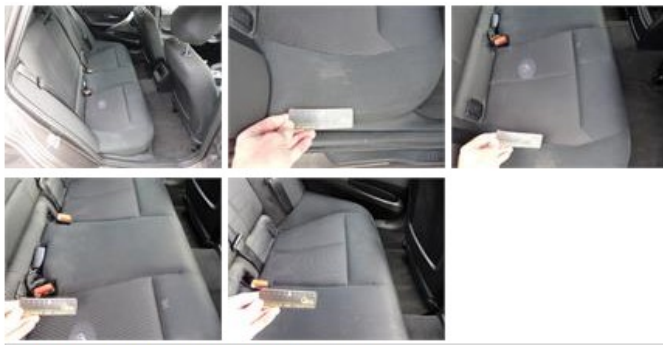
Repair kit	Yes	Compressor	Yes
Total cost ex VAT			30,00
Seat cover R, Stain, Cleaning			25,00
