**BMW 5 TOURING: 1NAX286**

**Limited Technical Inspection**

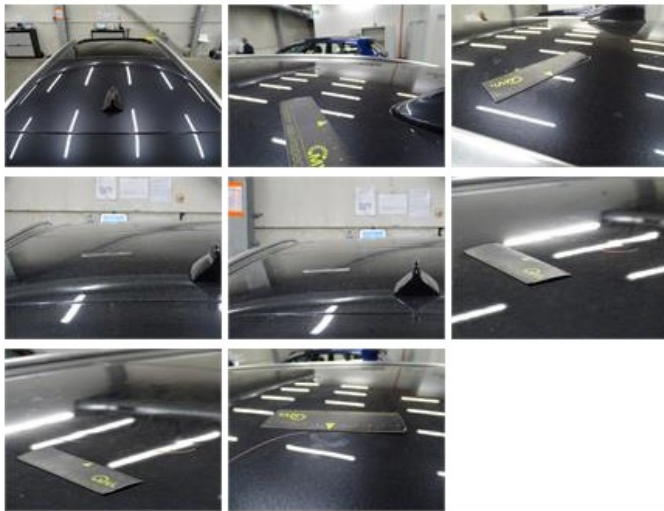
Roof, Bad repair, Acceptable

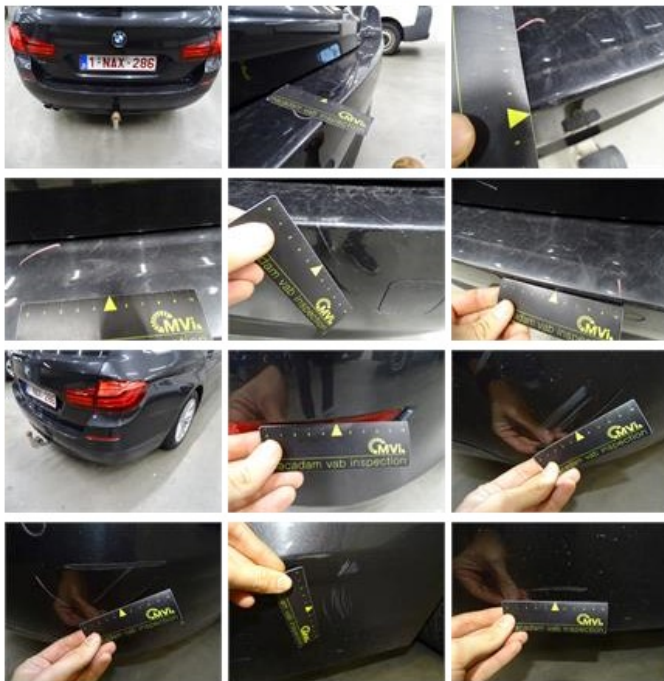
Bumper R, Dent(s) and scratch(es), LI - Repair and paint (complete)

254,16

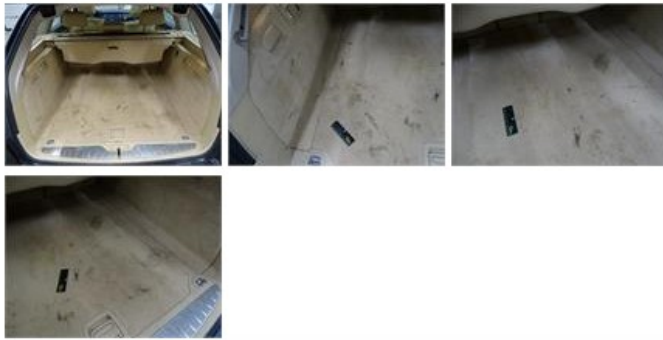
Boot carpet, Stain, Cleaning

25,00

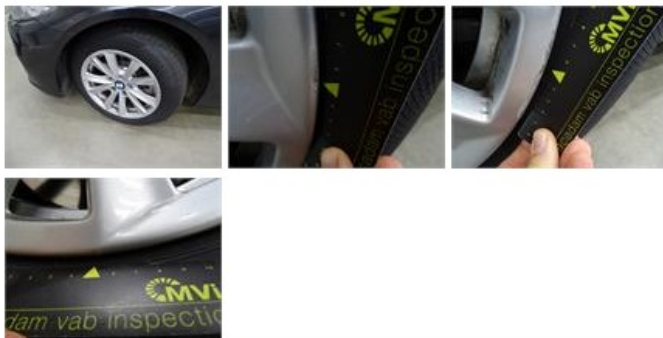
Alloy rim F L, Scratch(es), LI - Repair and paint (complete)

95,00
