BMW 3: 1GXL754			
Vinnumber:	WBA3L11080K176630	Versionname:	3 TOURING 320d Eff.Dyn.Ed. 163PK
First Registrationdate:	27/05/2014	Fiscalpower:	
Expertise Mileage:	125643	Power Kw:	120
Bodytype:		Body color:	Grey
Gearbox:	MAN 6 VIT	Paint type:	Metalic
Transmission:	Back	Rims summer:	Aluminium
Fueltype:	Diesel	Oil level:	OK
Battery functioning:	Yes	Parking lot:	1526
Number of doors:	5		
Number of seats:	5		
Number head rests:	5		
Rims summer:	Aluminium		
Category:	Passenger Car		
Oil level:	OK		
Registration Certificate Car (BE):	Yes

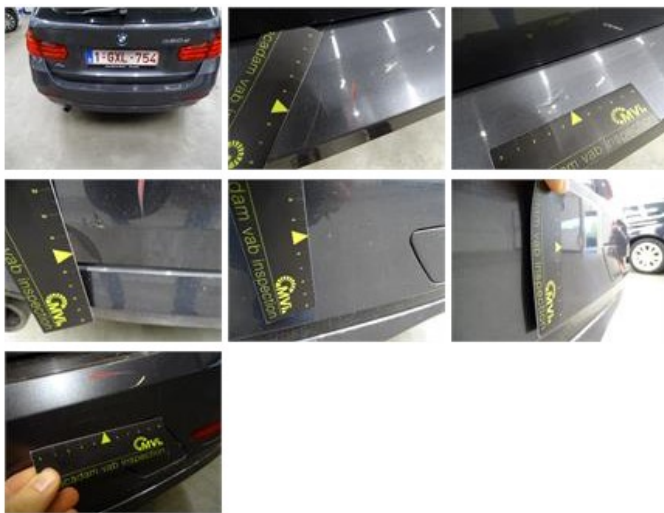
Total cost ex VAT	2800,59
Bumper R, Dent(s) and scratch(es), LI - Repair and paint (complete)	211,80

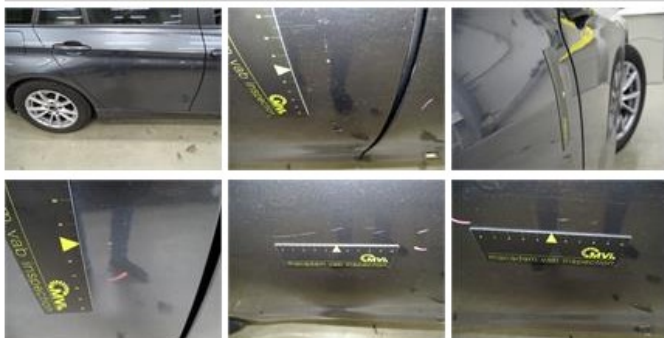
Door R R, Scratch(es), LI - Repair and paint (complete)

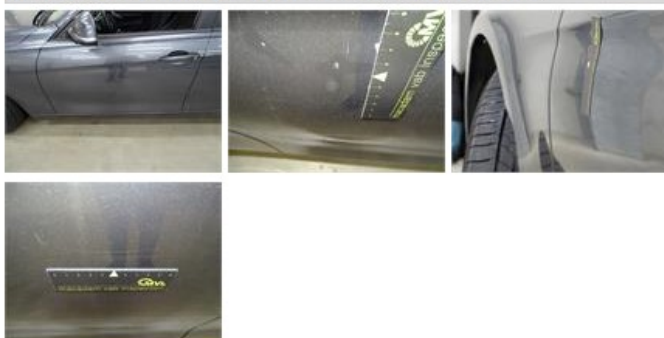
Door F L, Dent(s) and scratch(es), LI - Repair and paint (complete)

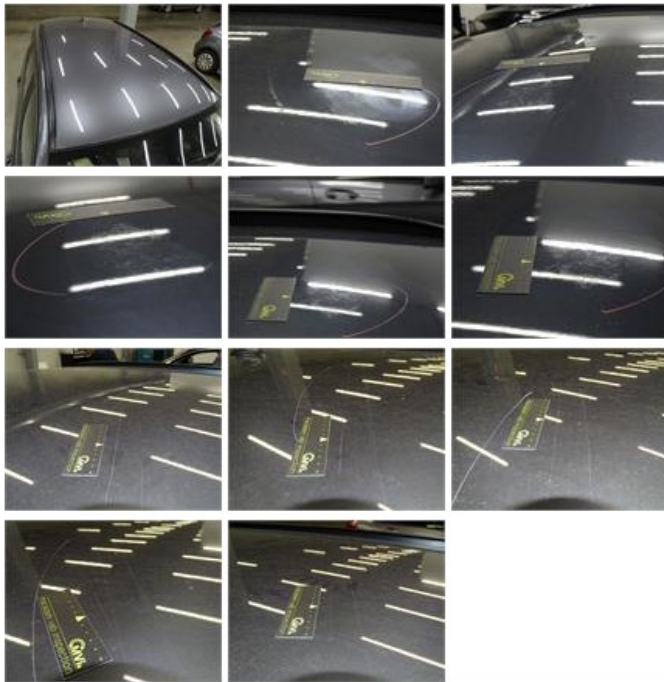
Roof, Chemical pollution, LI - Repair and paint (complete)

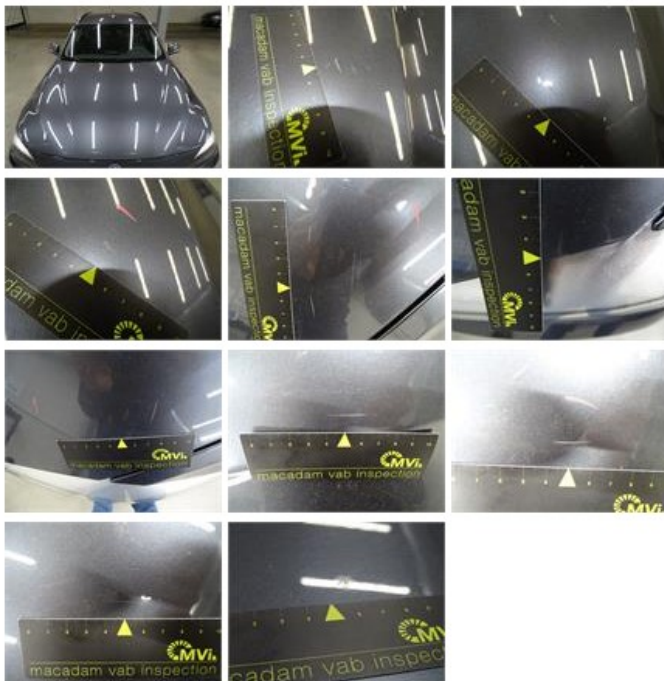
Bonnet, Scratch(es), LI - Repair and paint (complete)

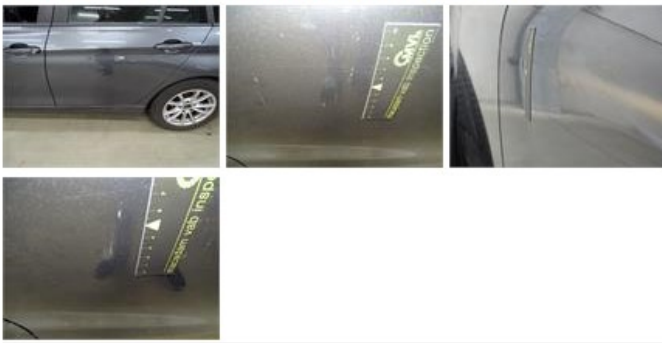
Door R L, Dent(s) and scratch(es), LI - Repair and paint (complete)

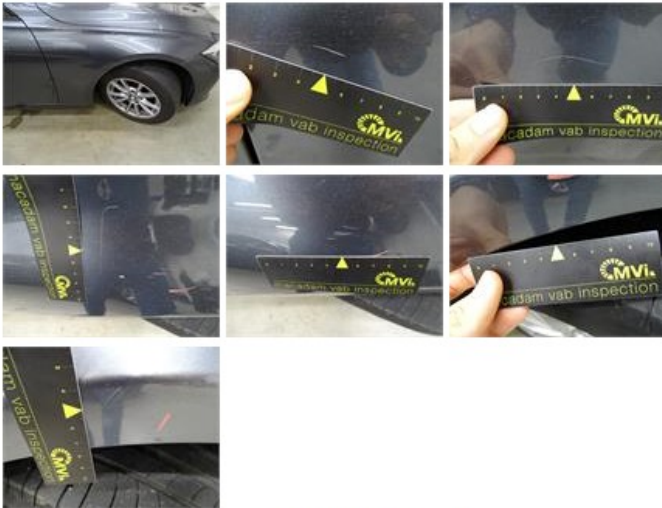
Wing F R, Scratch(es), LI - Repair and paint (complete)

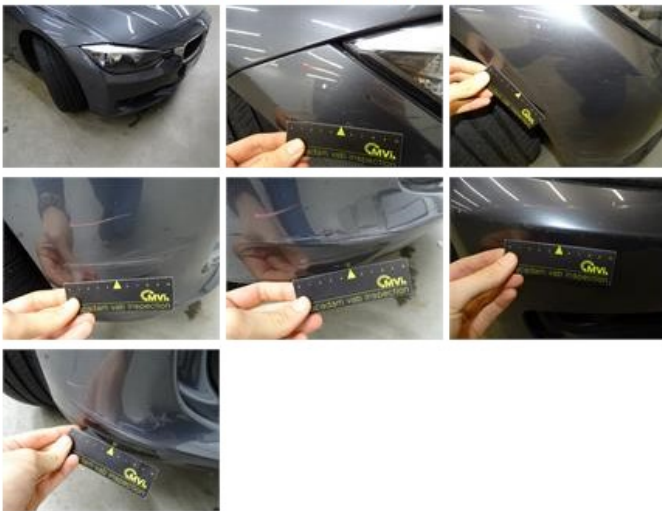
Bumper F, Scratch(es), LI - Repair and paint (complete)
