AUDI A4 AVANT: 1LKX534

Limited Technical Inspection

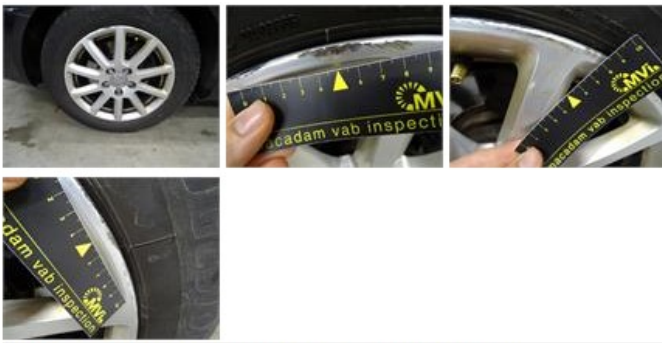
Total cost ex VAT	2557,57
Alloy rim R R, Scratch(es), LI - Repair and paint (complete)	95,00

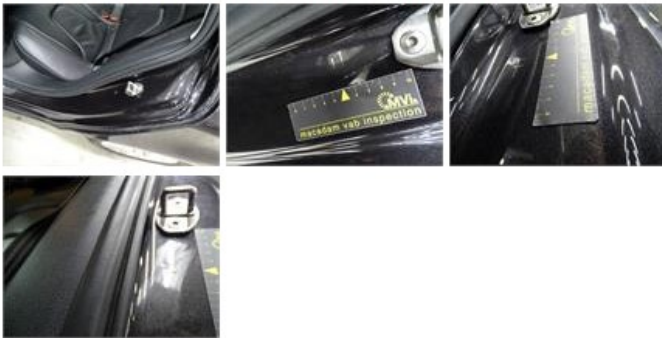
Rocker panel inner R L, Dent(s), LI - Repair and paint (complete)	115,56
---	--------

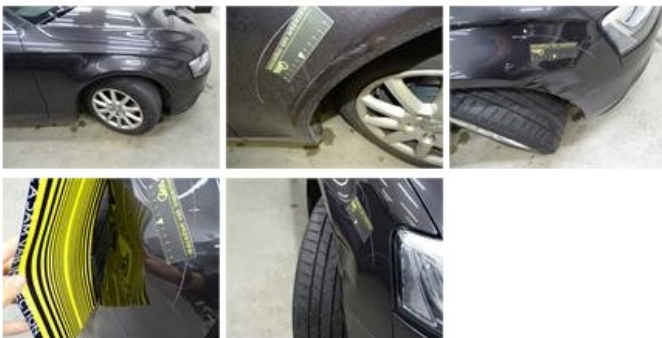
Wing F R, Dent(s) and scratch(es), LI - Repair and paint (complete)	268,18
---	--------

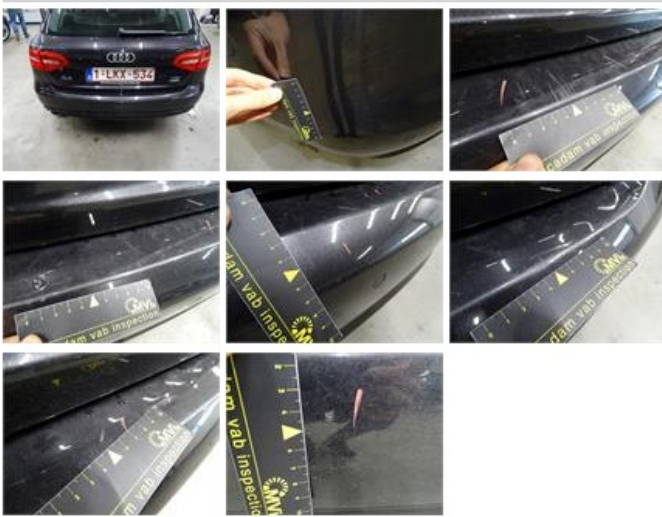
Bumper R, Scratch(es), LI - Repair and paint (complete)	211,80
---	--------

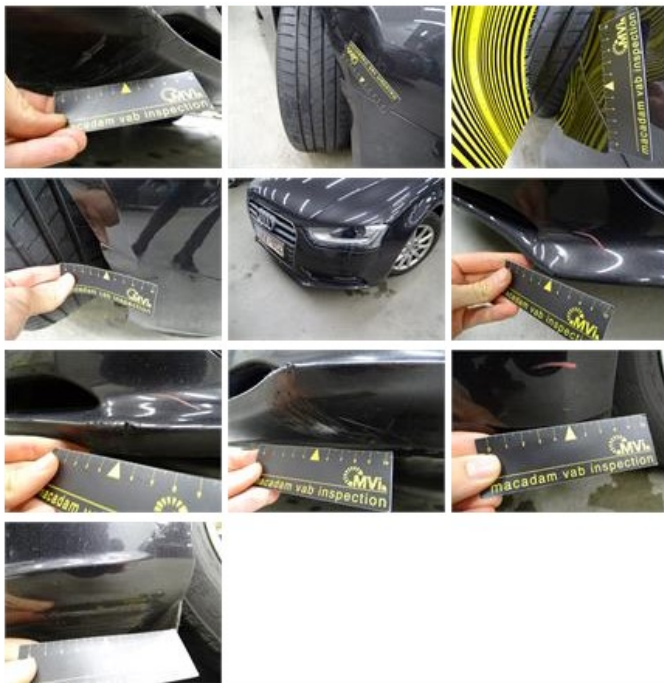
Bumper F, Dent(s) and scratch(es), LI - Repair and paint (complete)	211,80
---	--------

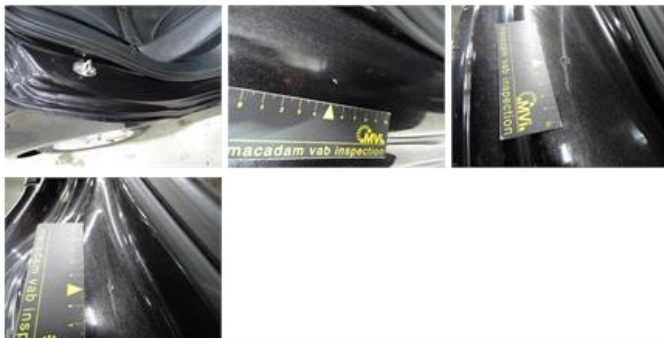
Rocker panel inner R R, Dent(s), LI - Repair and paint (complete) 115,56

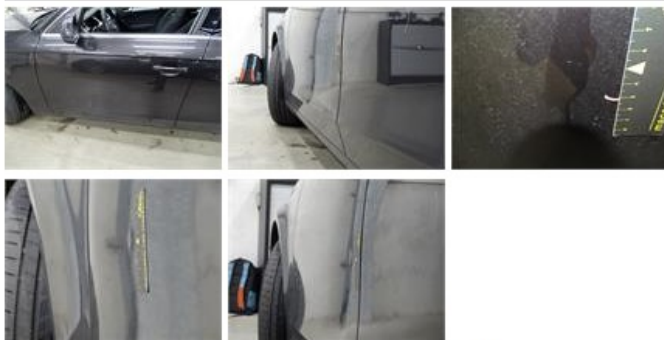
Door F L, Dent(s) and scratch(es), LI - Repair and paint (complete) 318,35

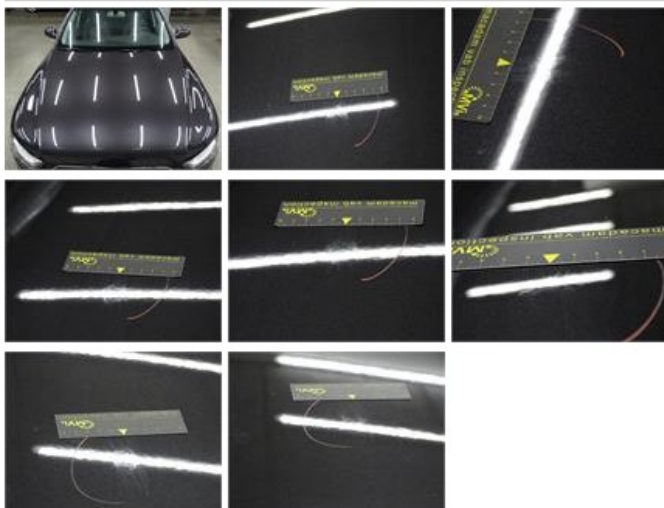
Bonnet, Chemical pollution, LI - Repair and paint (complete) 290,08

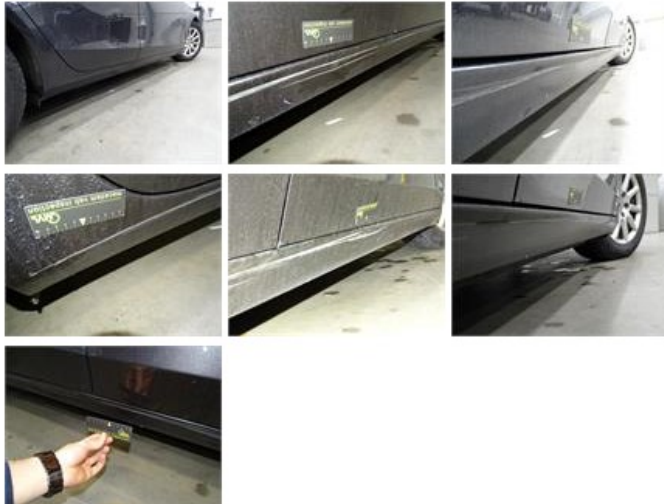
Sill outer R, Dent(s) and scratch(es), LI - Repair and paint (complete)

310,50

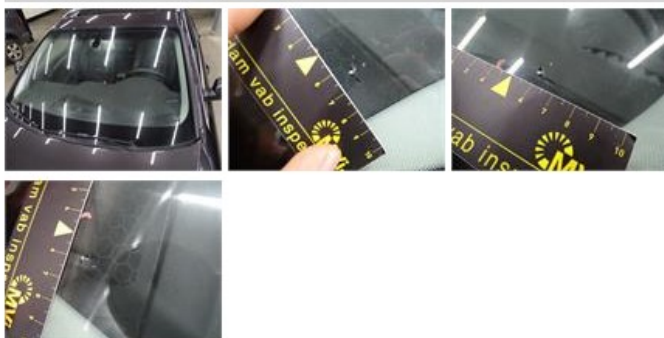
Windscreen, Stone chip(s), Windscreen repair

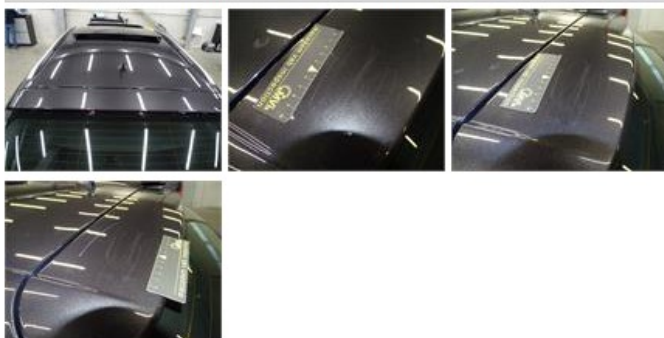
Rear spoiler, Scratch(es), LI - Repair and paint (complete)

115,56

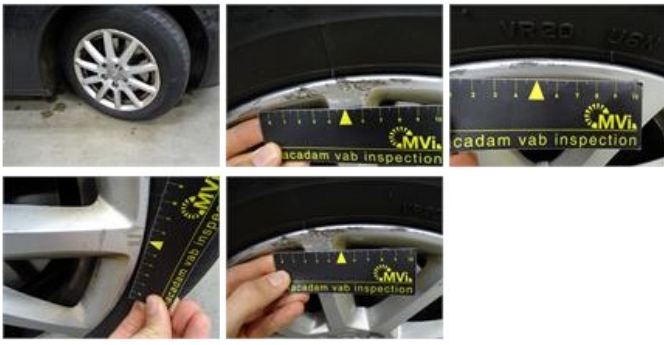
Alloy rim F R, Scratch(es), LI - Repair and paint (complete)

95,00
