**BMW 5: 1JAJ608**

**Limited Technical Inspection**

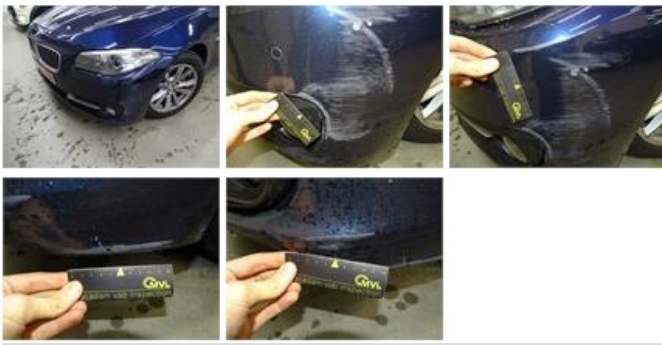
<b>Total cost ex VAT</b>	<b>827,40</b>
<b>Bumper F, Scratch(es), LI - Repair and paint (complete)</b>	<b>254,16</b>

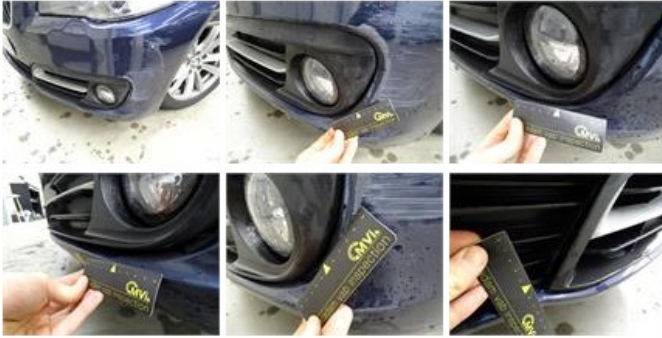
Bumper grille F L, Broken, E - Replace 34,08

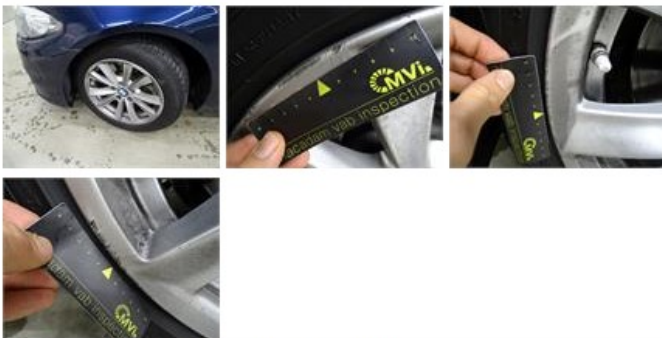
Alloy rim F L, Scratch(es), LI - Repair and paint (complete) 95,00

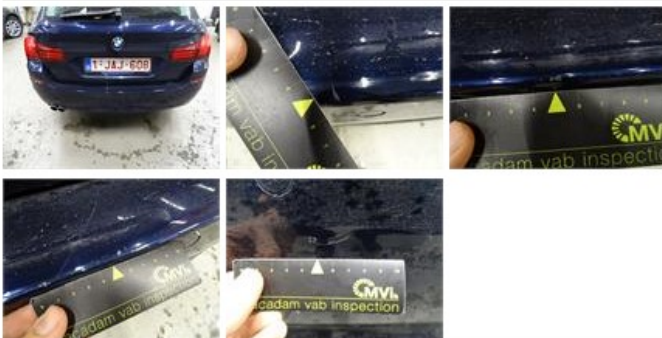
Bumper R, Scratch(es), LI - Repair and paint (complete) 254,16

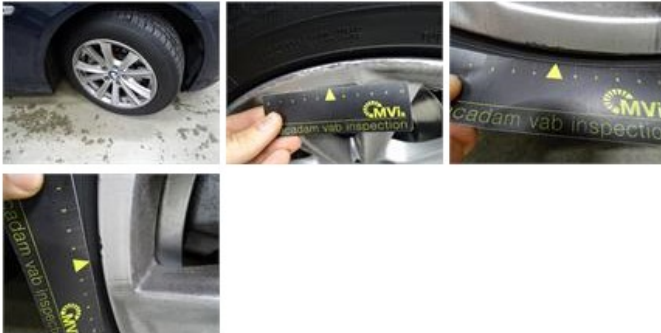
Alloy rim F R, Scratch(es), LI - Repair and paint (complete) 95,00
