<b>BMW X4: 1LEH289</b>			
Vinnumber:	<b>WBAXX110200R35726</b>	Versionname:	<b>2.0 XDRIVE20D (120KW) 4WD</b>
First Registrationdate:	<b>4/09/2015</b>	Fiscalpower:	
Expertise Mileage:	<b>124522</b>	Power Kw:	<b>120</b>
Bodytype:		Body color:	<b>Black</b>
Gearbox:	<b>Automatic</b>	Paint type:	<b>Metalic</b>
Transmission:	<b>4 Weel</b>	Rims summer:	<b>Aluminium</b>
Fueltype:	<b>Diesel</b>	Oil level:	<b>OK</b>
Battery functioning:	<b>Yes</b>	Parking lot:	<b>4332</b>
Number of doors:	<b>5</b>		
Number of seats:	<b>5</b>		
Number head rests:	<b>5</b>		
Rims summer:	<b>Aluminium</b>		
Category:	<b>Passenger Car</b>		
Oil level:	<b>OK</b>		
Registration Certificate Car (BE):	<b>Yes</b>

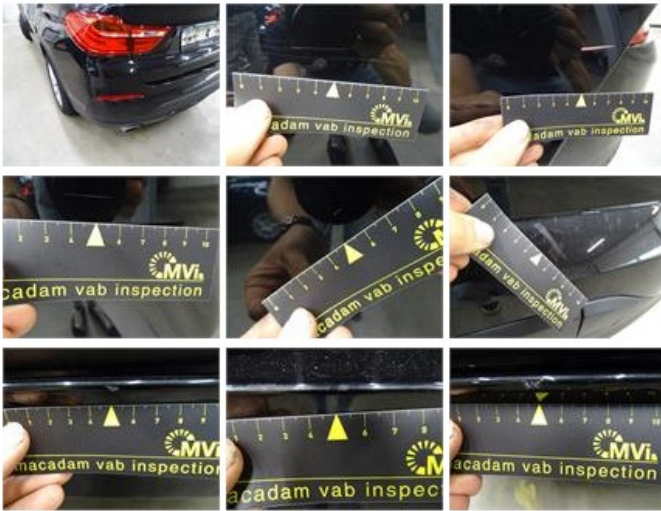
Bumper R, Scratch(es), LI - Repair and paint (complete) 254,16

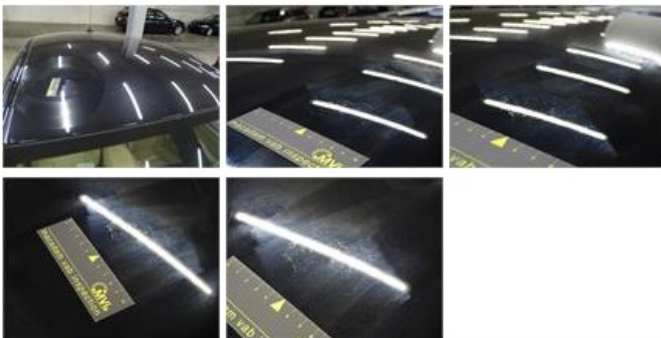
Roof, Chemical polution, LI - Repair and paint (complete) 577,80

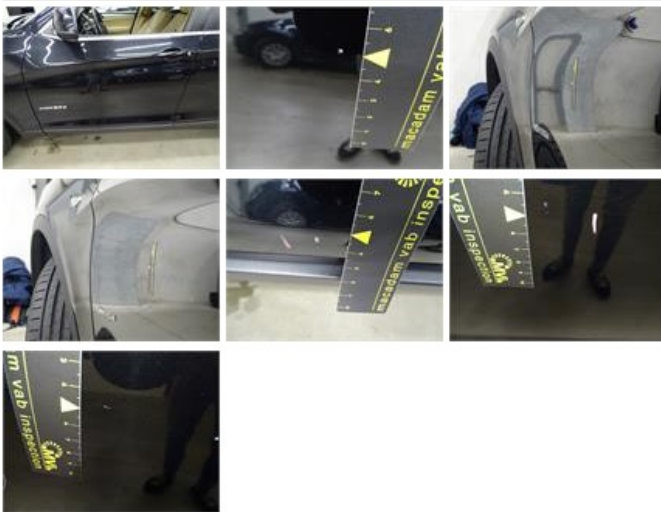
Door F L, Dent(s) and scratch(es), LI - Repair and paint (complete) 382,02

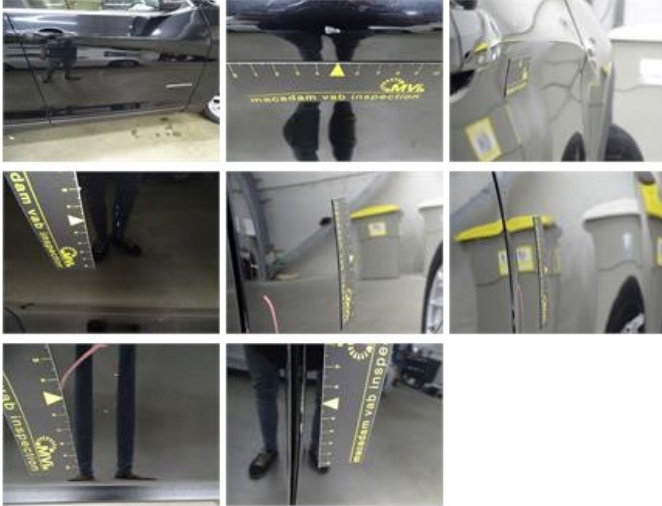
Door F R, Dent(s) and scratch(es), LI - Repair and paint (complete) 382,02
