AUDI A5 SPORTBACK: 1LVB910

Limited Technical Inspection

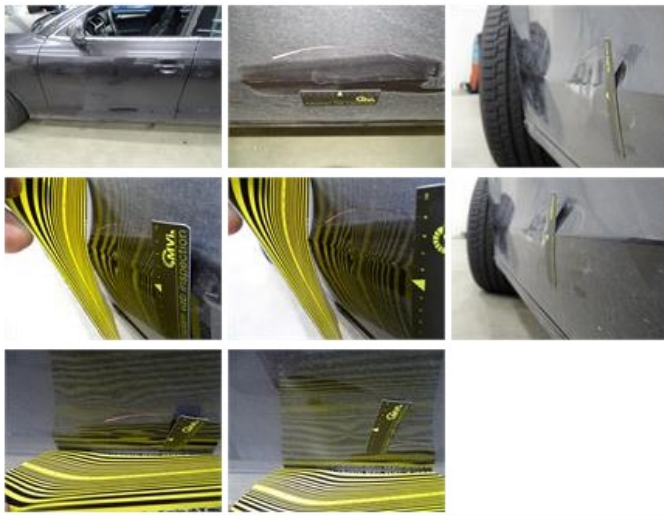
Total cost ex VAT	1720,07
Door F L, Dent(s) and scratch(es), LI - Repair and paint (complete)	382,02

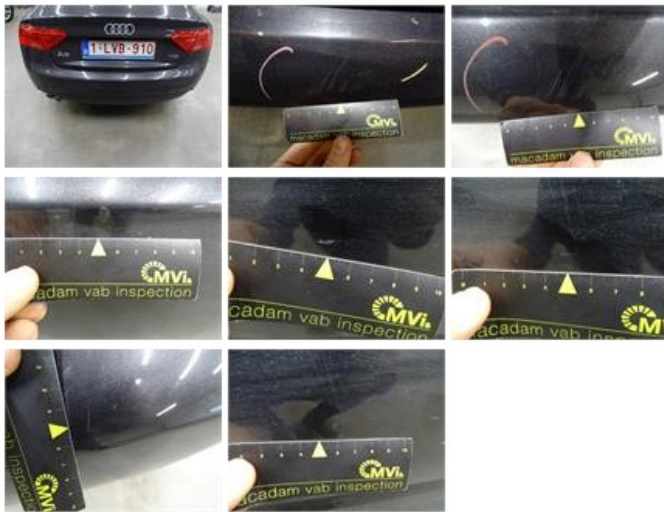
Alloy rim F R, Scratch(es), Acceptable	0,00
<i>No pictures to display</i>	
Wing R R, Scratch(es), Acceptable	0,00
<i>No pictures to display</i>	
Tailgate, Scratch(es), Acceptable	0,00
<i>No pictures to display</i>	
Bumper R, Scratch(es), LI - Repair and paint (complete)	254,16

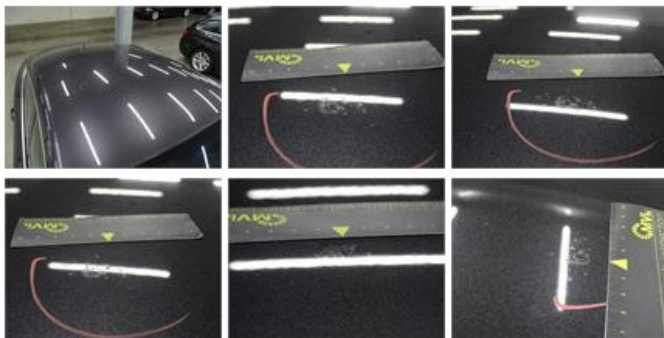
Roof, Chemical pollution, LI - Repair and paint (complete)	577,80
------------------------------------------------------------	--------
