**BMW 5 TOURING: 1KNL893**

**Limited Technical Inspection**

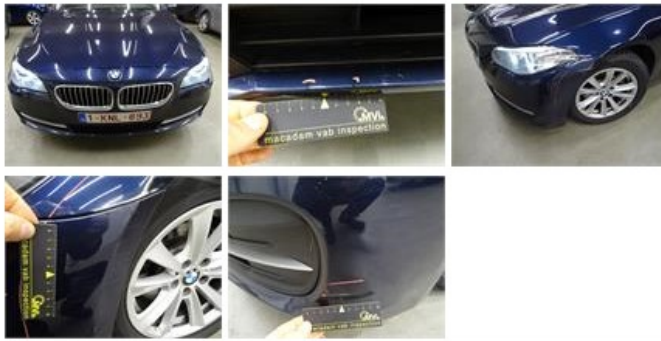
Bumper F, Dent(s) and scratch(es), LI - Repair and paint (complete) 254,16

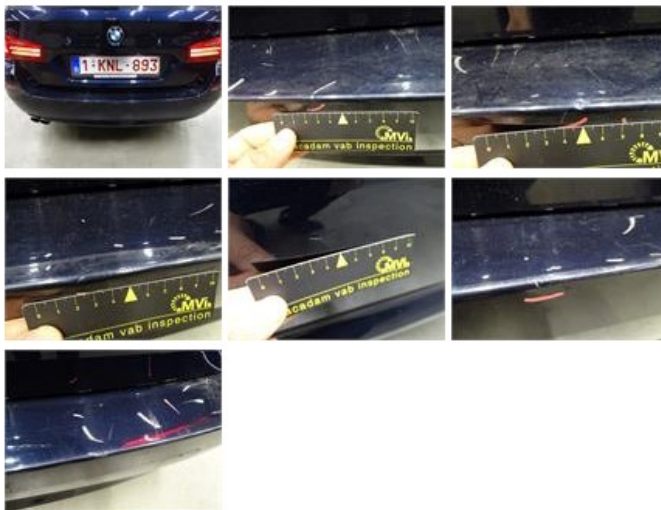
Bumper R, Scratch(es), LI - Repair and paint (complete) 254,16
