**LAND ROVER RANGE ROVER EVOQUE: 1PDF177**

**Limited Technical Inspection**

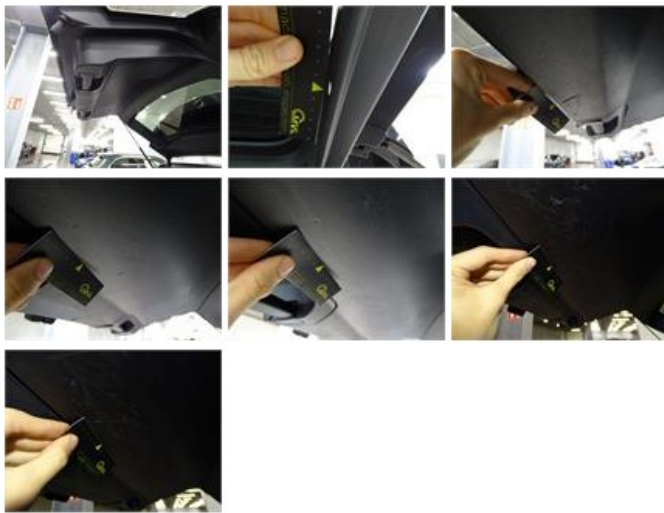
<b>Total cost ex VAT</b>	<b>935,75</b>
<b>Trunk lid covering R, Scratch(es), Smart repair</b>	<b>110,64</b>

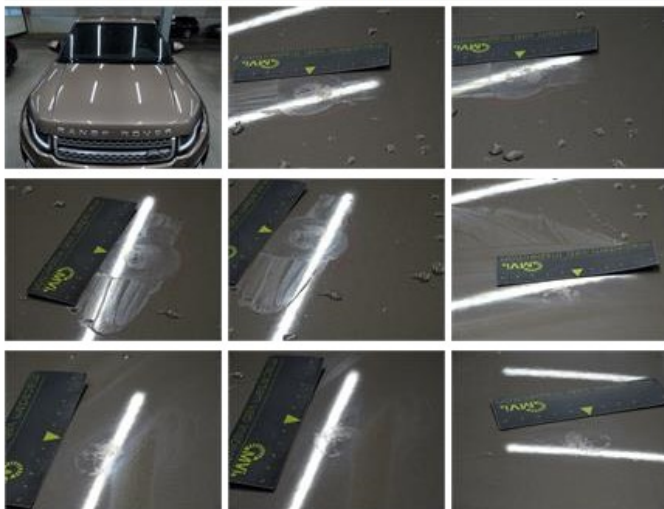
Alloy rim F R, Scratch(es), Acceptable	0,00
<i>No pictures to display</i>	
Door F R, Scratch(es), Acceptable	0,00
<i>No pictures to display</i>	
Door R R, Scratch(es), Acceptable	0,00
<i>No pictures to display</i>	
Wing F L, Scratch(es), Acceptable	0,00
<i>No pictures to display</i>	
Wing R L, Scratch(es), Acceptable	0,00
<i>No pictures to display</i>	
Roof, Dent(s), Acceptable	0,00
<i>No pictures to display</i>	
Bonnet, Chemical polution, LI - Repair and paint (complete)	348,09

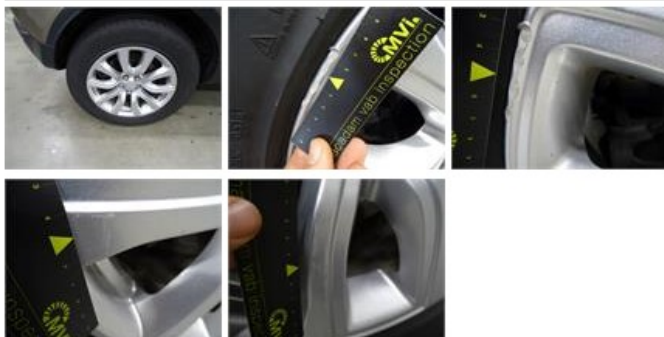
Alloy rim R R, Scratch(es), LI - Repair and paint (complete)	95,00
--	-------

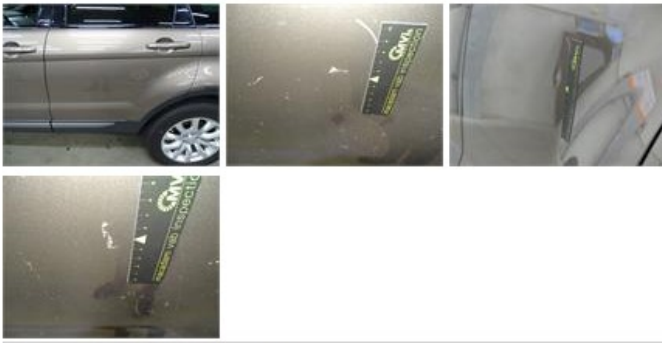
Door F L, Scratch(es), Acceptable	0,00
<i>No pictures to display</i>	
Wing trim R R, Scratch(es), 67 - Polish	0,00
<i>No pictures to display</i>	
Bumper corner R R, Scratch(es), Acceptable	0,00
<i>No pictures to display</i>	
Door R L, Dent(s) and scratch(es), LI - Repair and paint (complete)	382,02
