**RENAULT KADJAR: CX7455**

**Limited Technical Inspection**

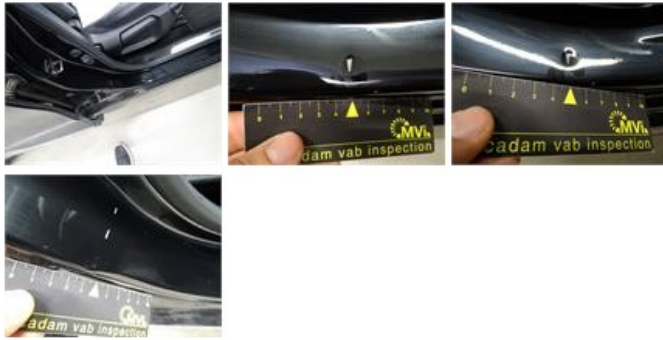
Rocker panel inner F R, Dent(s), LI - Repair and paint (complete)

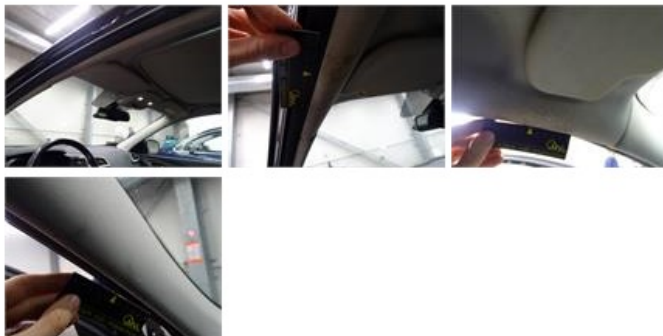
Interior, Smell, Ozone treatment

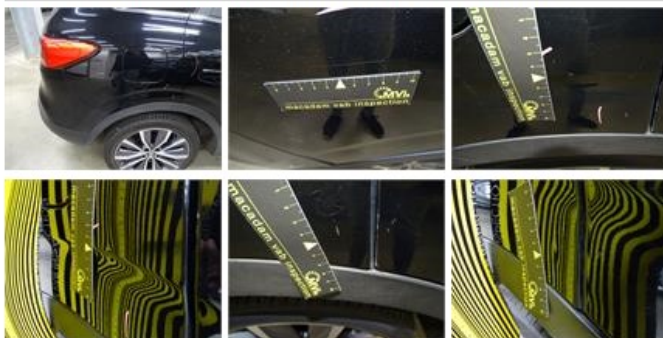
Wing R R, Dent(s) and scratch(es), LI - Repair and paint (complete)

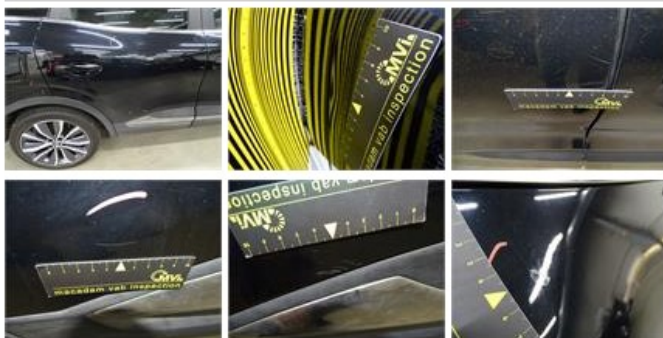
Door R R, Dent(s) and scratch(es), LI - Repair and paint (complete)

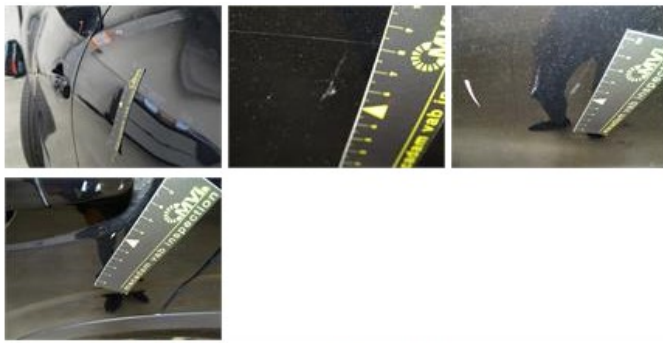
Door R L, Dent(s) and scratch(es), LI - Repair and paint (complete)

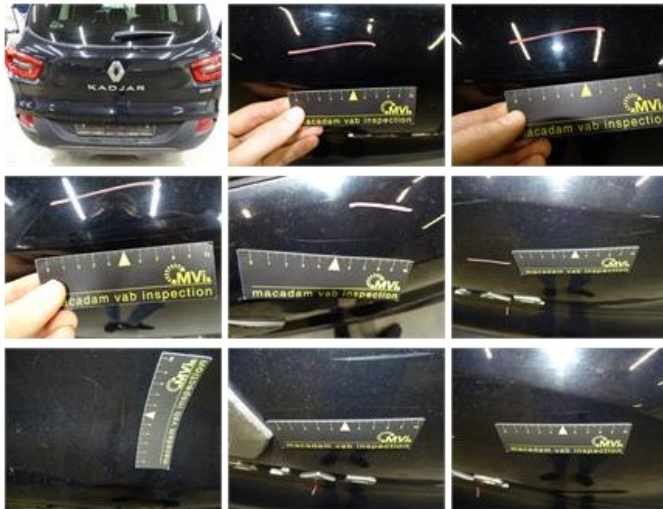
Tailgate, Scratch(es), LI - Repair and paint (complete)

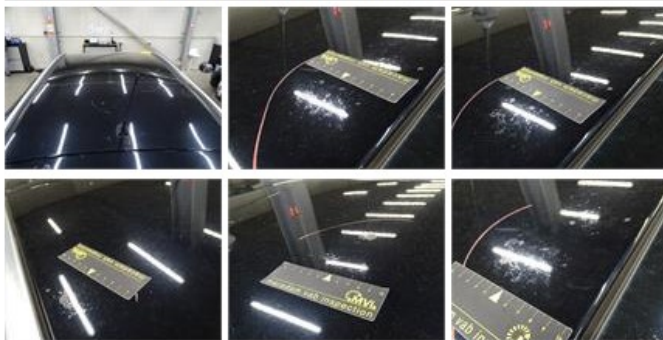
Roof, Chemical polution, LI - Repair and paint (complete)

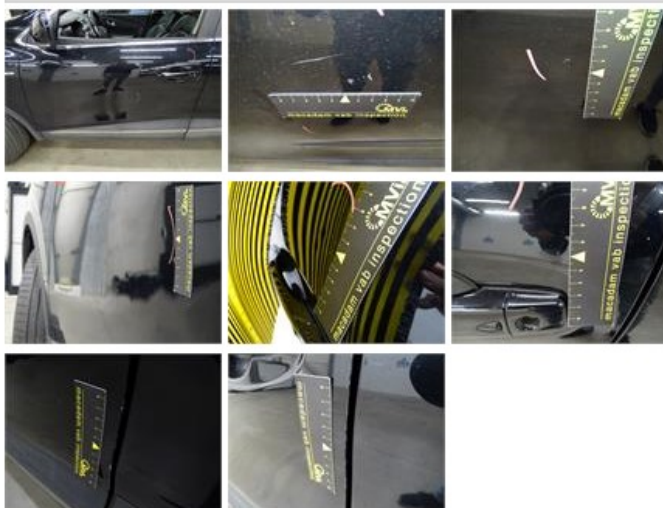
Door F L, Dent(s) and scratch(es), LI - Repair and paint (complete)

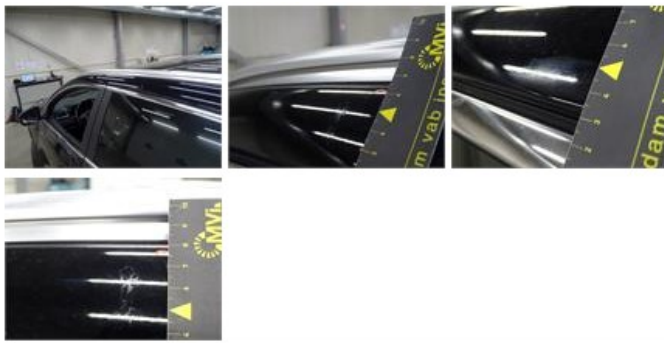
Roof pillar L, Chemical polution, LI - Repair and paint (complete)

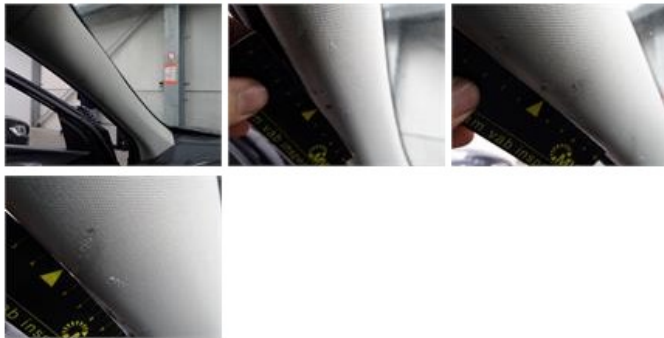
Covering interior A pillar L, Hole, E - Replace 51,61

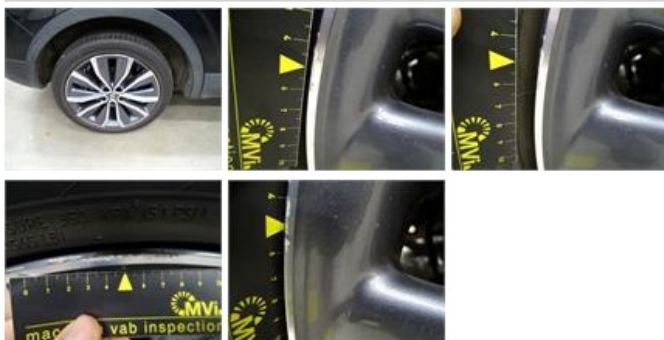
Alloy rim R R polished, Scratch(es), LI - Repair and paint (complete) 95,00

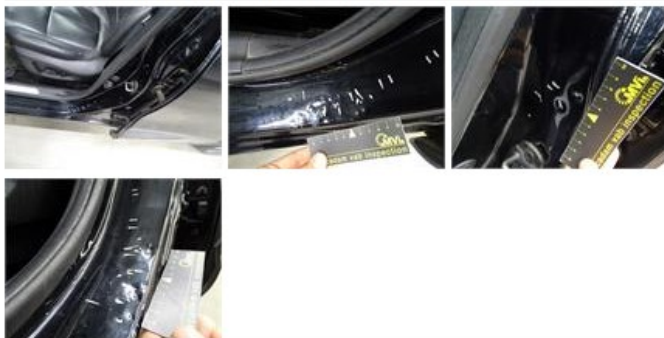
Rocker panel inner F L, Dent(s), LI - Repair and paint (complete) 115,56

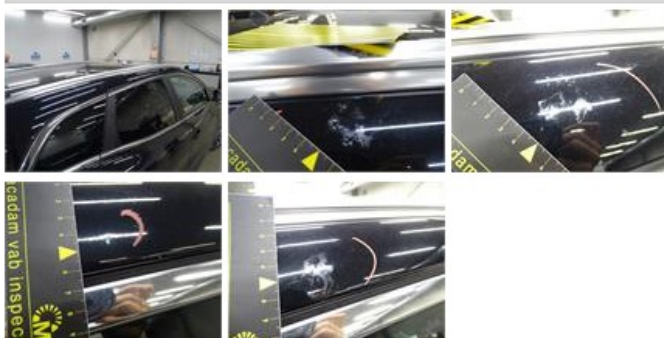
Roof pillar R, Chemical polution, LI - Repair and paint (complete) 220,18

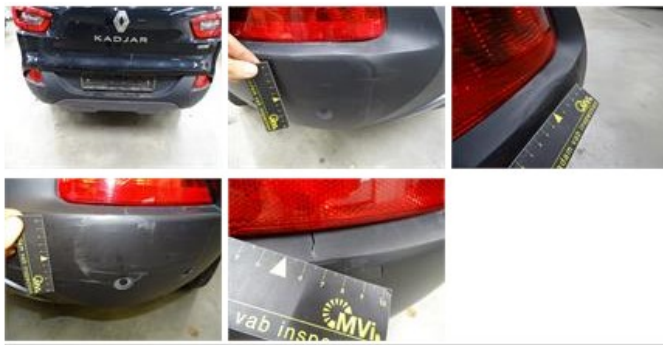
Bumper R, Broken, E - Replace 415,20

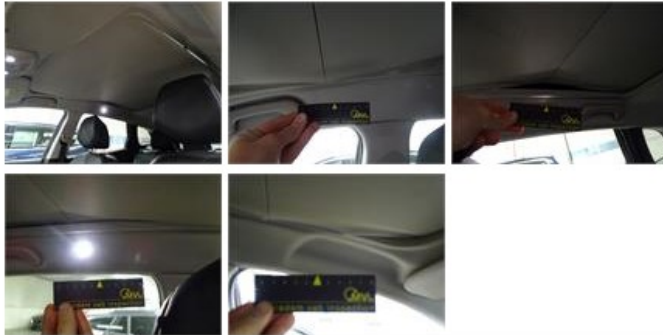
Sunroof cover, Broken, E - Replace

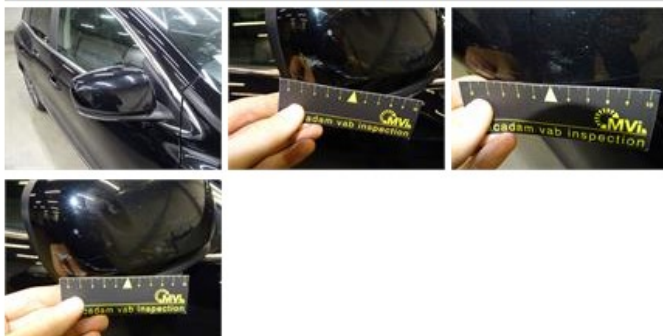
Rearview mirror housing R, Scratch(es), LI - Repair and paint (complete)

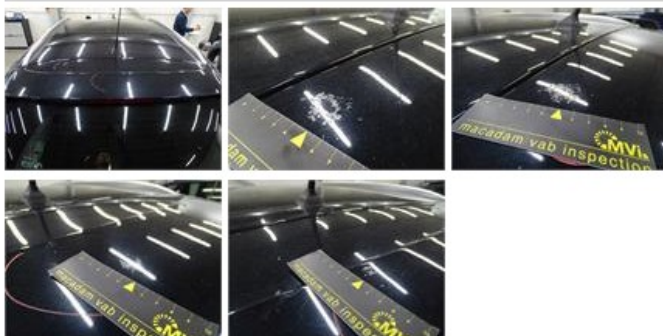
Rear spoiler, Chemical polution, LI - Repair and paint (complete)
