**PEUGEOT 308 SW: 1LEL219**

**Limited Technical Inspection**

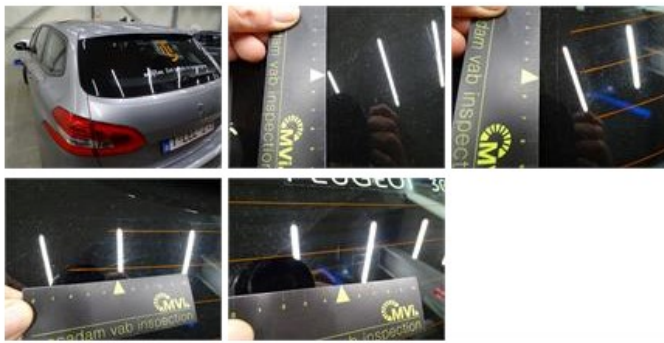
| Rear window, Scratch(es), E - Replace | 370,00 |

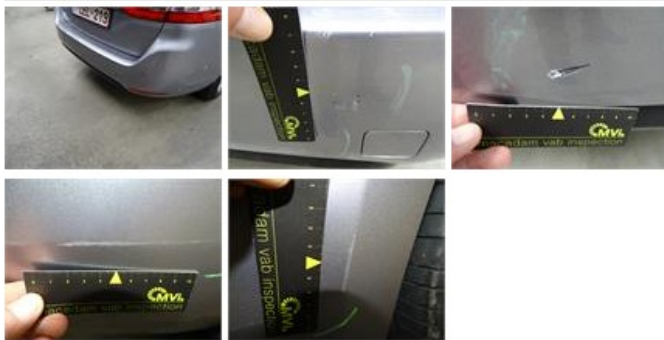
| Bumper R, Scratch(es), LI - Repair and paint (complete) | 211,80 |

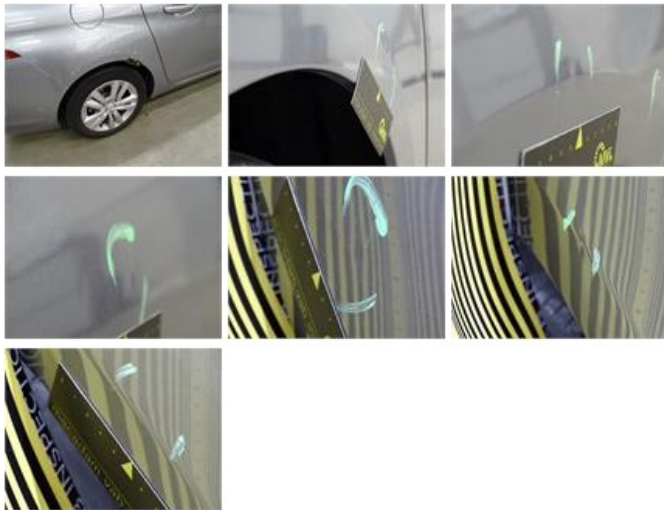
| Wing R R, Dent(s), LI - Repair and paint (complete) | 308,20 |

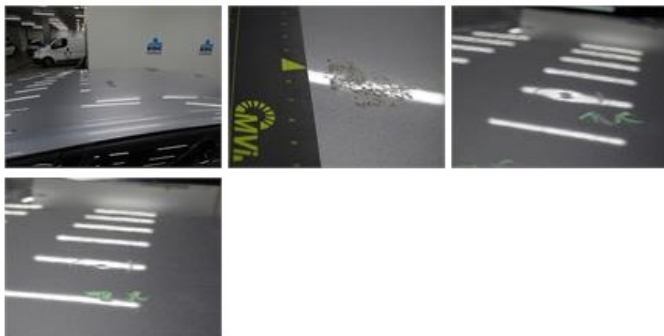
| Roof, Chemical polution, LI - Repair and paint (complete) | 505,50 |
