# OPEL Astra: 1HNF770

## Limited Technical Inspection

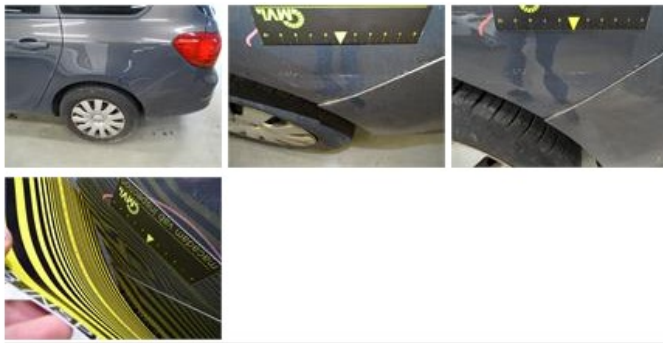
| Wing R L, Dent(s) and scratch(es), LI - Repair and paint (complete) | 308,20 |

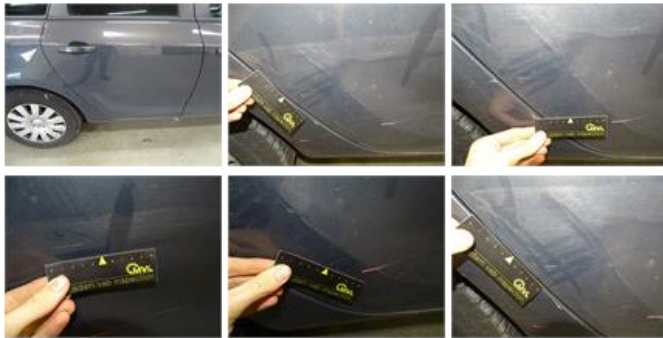
Door R R, Scratch(es), LI - Repair and paint (complete)

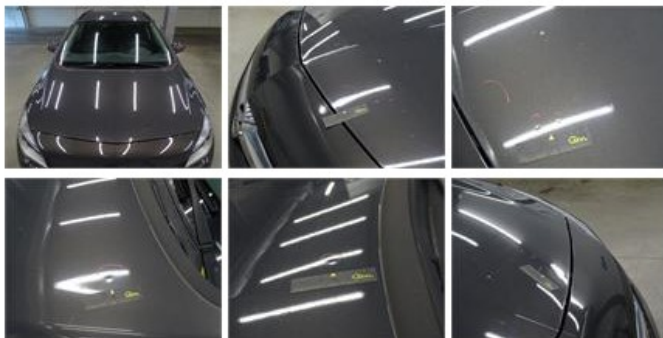
Bonnet, Dent(s), PDR - Paintless dent repair

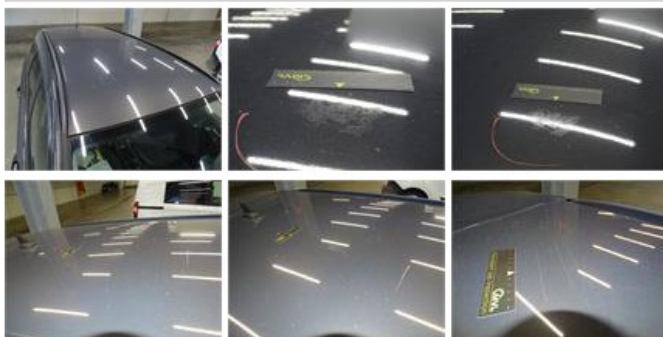
Roof, Chemical polution, LI - Repair and paint (complete)

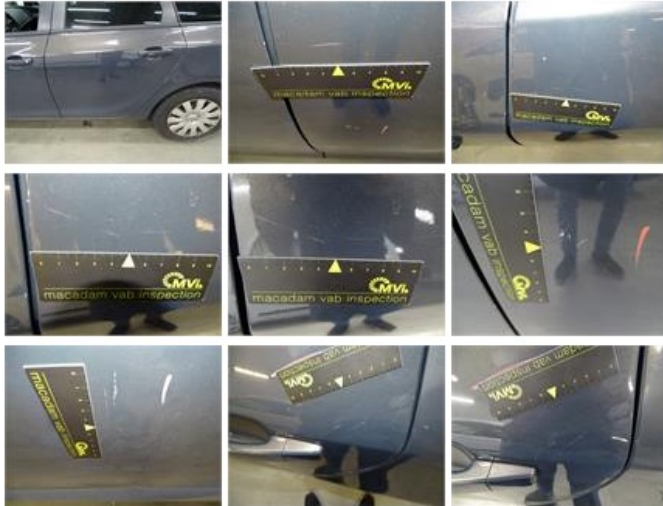
Door R L, Scratch(es), LI - Repair and paint (complete)

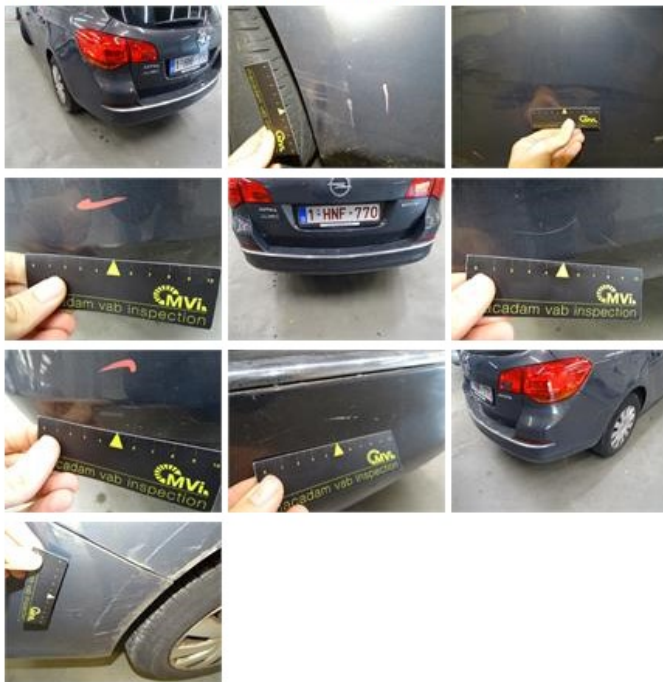
Bumper R, Scratch(es), LI - Repair and paint (complete)

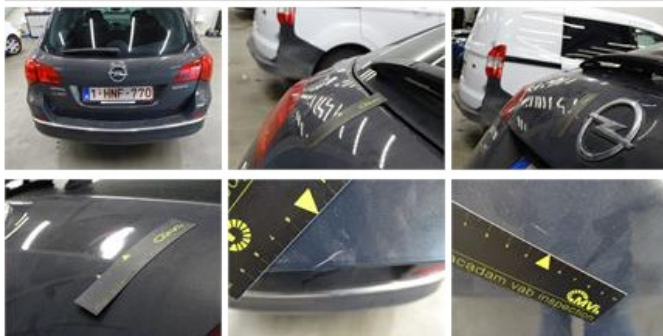
Tailgate, Dent(s) and scratch(es), LI - Repair and paint (complete)

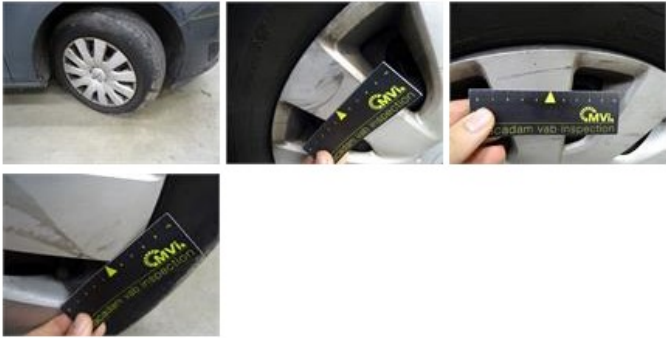
| Wheel cover F R, Scratch(es), E - Replace | 30,00 |
