## VOLKSWAGEN PASSAT VARIANT: 1LAR353

| Vinnumber: | WVWZZZ3CZGE019393 | Versionname: | 1.6 TDI VARIANT COMFORTLINE |

## Limited Technical Inspection

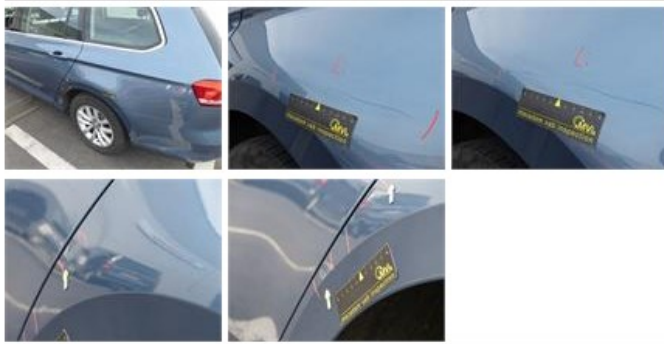
| Wing R L, Dent(s) and scratch(es), LI - Repair and paint (complete) | | | 308,20 |

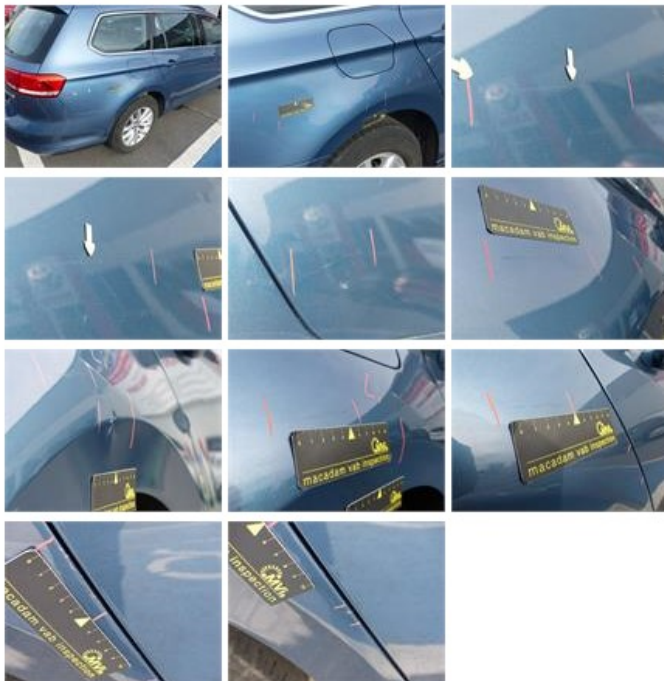
| Wing R R, Dent(s) and scratch(es), LI - Repair and paint (complete) | 308,20 |

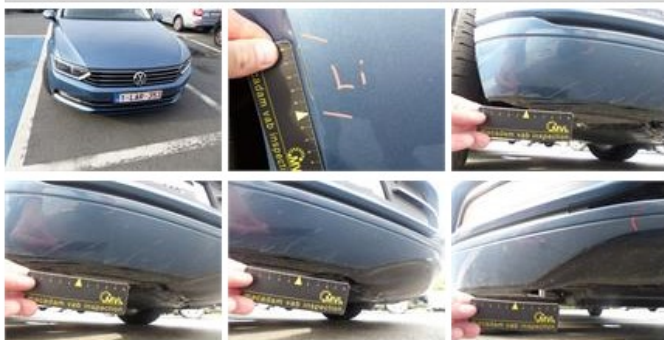
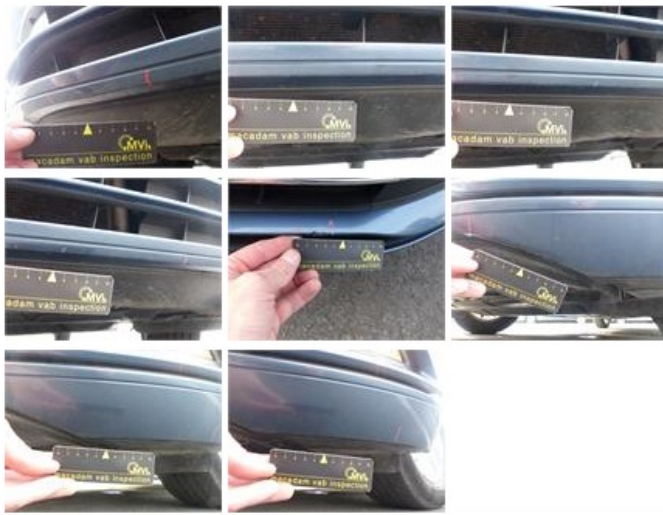
| Bumper F, Scratch(es), LI - Repair and paint (complete) | 211,80 |

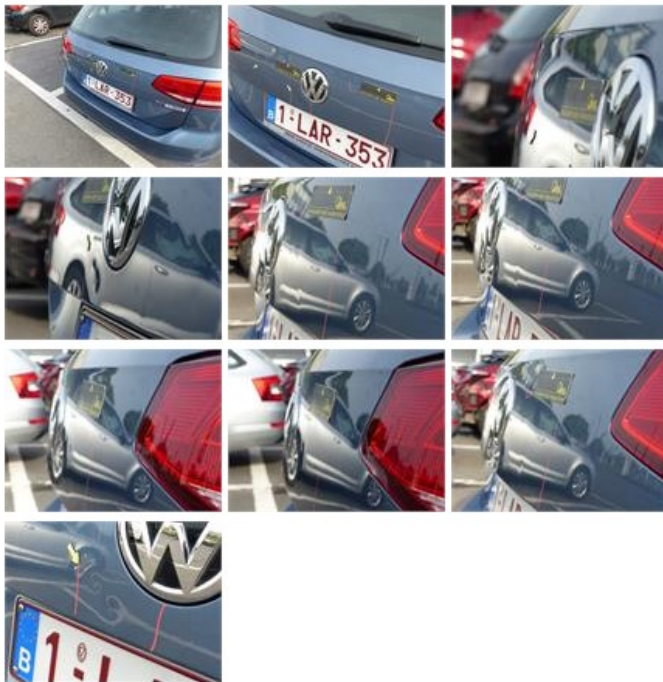
| Tailgate, Dent(s) and scratch(es), LI - Repair and paint (complete) | 301,68 |
