# VOLKSWAGEN GOLF VII: 1LAD197

| Vinnumber: | WVWZZZAUZGW057818 | Versionname: | 1.6 TDI 66KW TRENDLINE |

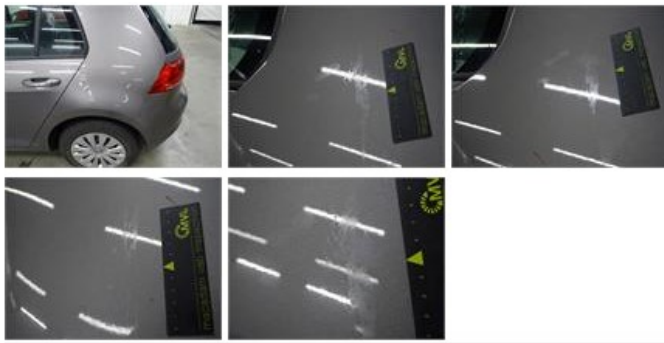
| Wing R L, Chemical polution, LI - Repair and paint (complete) | 308,20 |

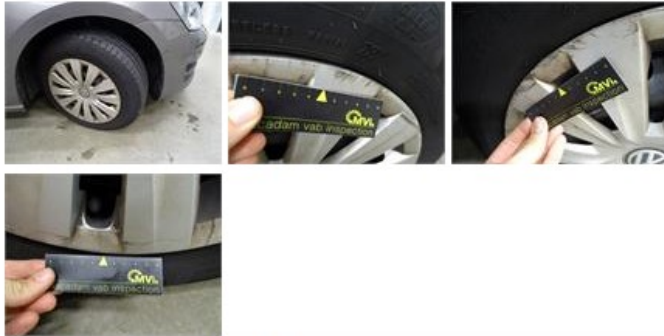
Wheel cover F R, Scratch(es), E - Replace 30,00

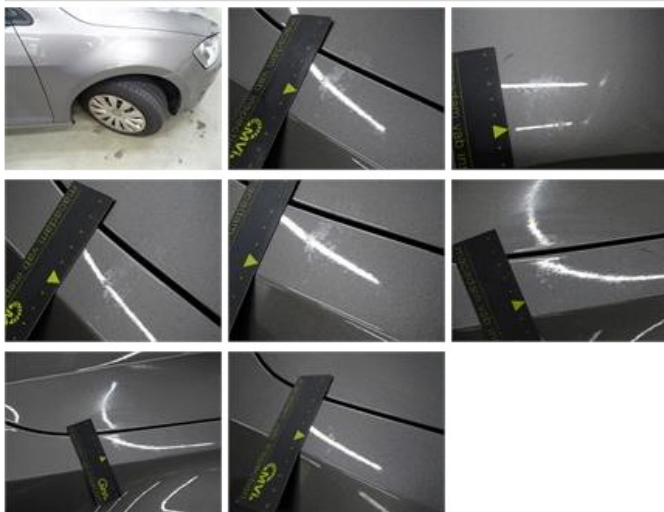
Wing F R, Chemical polution, LI - Repair and paint (complete) 220,18

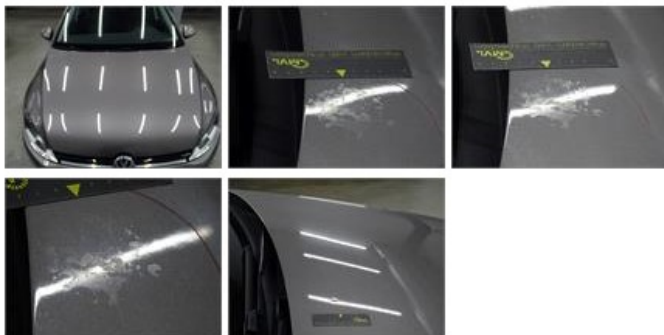
Bonnet, Chemical polution, LI - Repair and paint (complete) 290,08

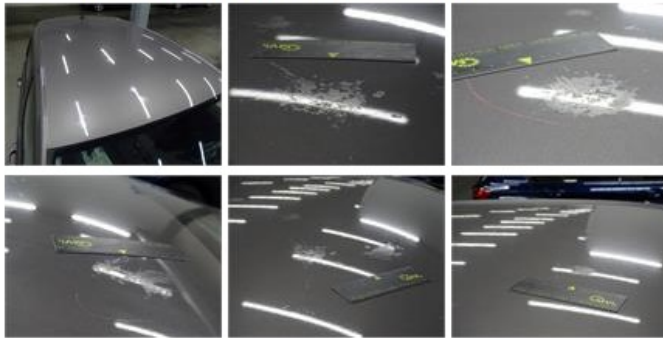
Roof, Chemical pollution, LI - Repair and paint (complete)

481,50

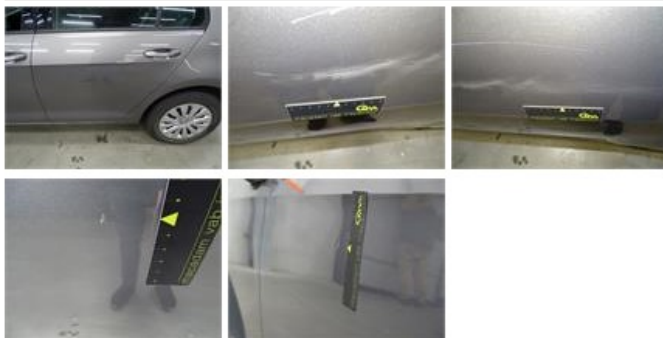
Door R L, Dent(s) and scratch(es), LI - Repair and paint (complete)

318,35

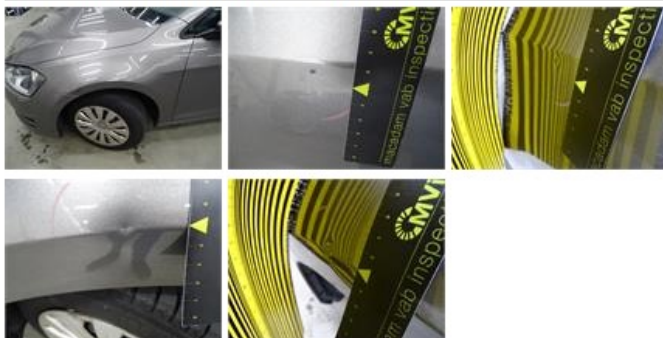
Wing F L, Dent(s) and scratch(es), LI - Repair and paint (complete)

220,18

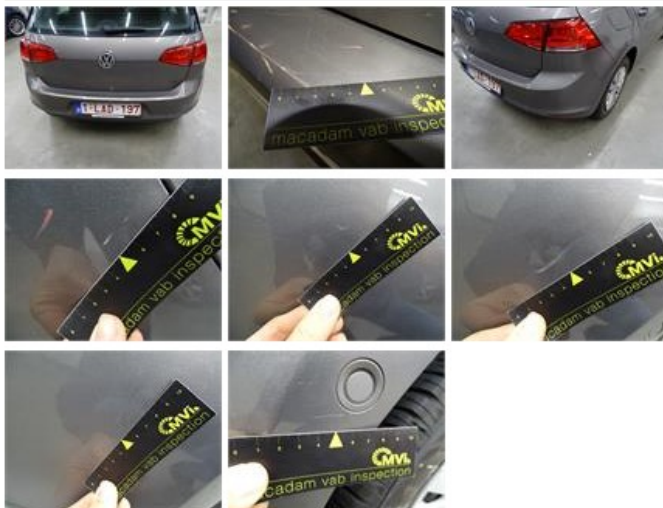
Bumper R, Scratch(es), LI - Repair and paint (complete)

211,80

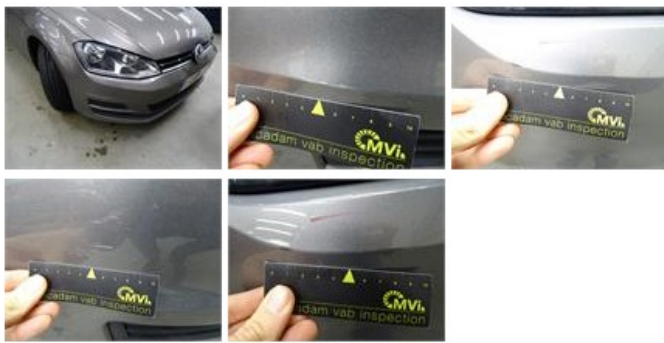
Bumper F, Scratch(es), LI - Repair and paint (complete)

211,80
