**VOLVO XC60: 1HNS779**

**Limited Technical Inspection**

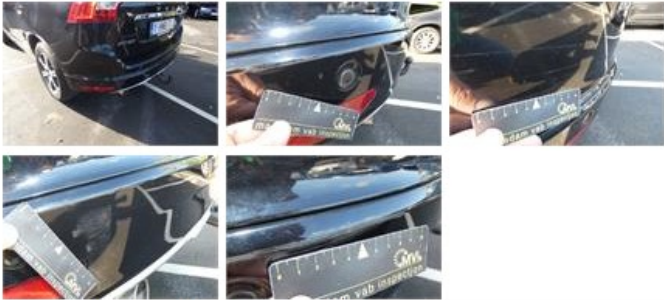
| Bumper R, Scratch(es), LI - Repair and paint (complete) | | 254,16 |
