**VOLVO XC90: 1LXU043**

| Vinnumber: | <b>YV1LFBABDG1059954</b> | Versionname: | <b>2.0 T8 4WD GEARTRONIC R-DESIGN 7PL</b> |

**Limited Technical Inspection**

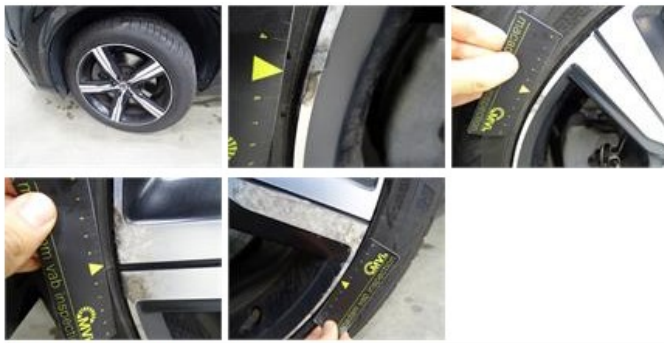
| Alloy rim F L polished, Scratch(es), LI - Repair and paint (complete) | <b>95,00</b> |

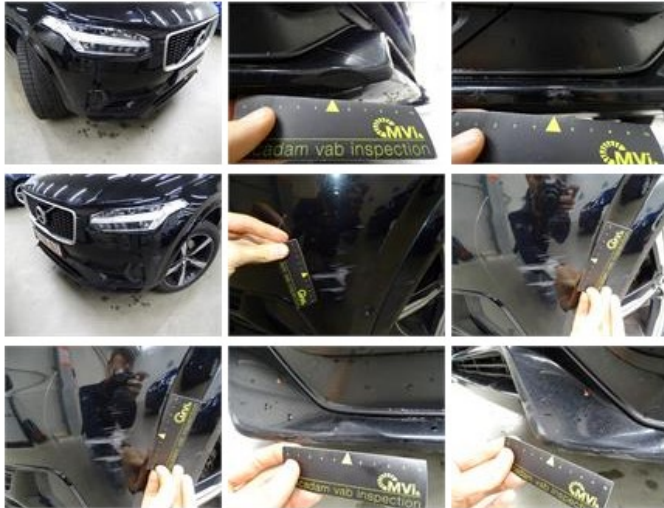
Bumper F, Dent(s) and scratch(es), LI - Repair and paint (complete) 254,16

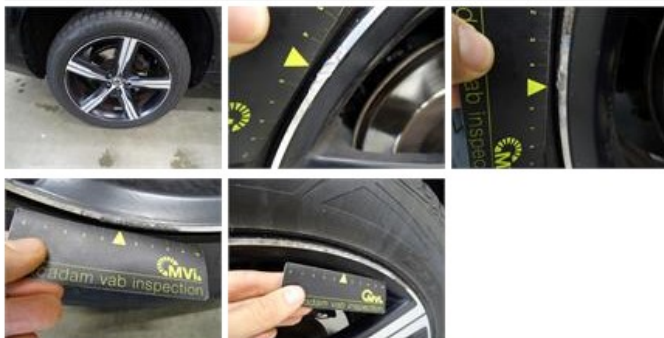
Alloy rim R R polished, Scratch(es), LI - Repair and paint (complete) 95,00

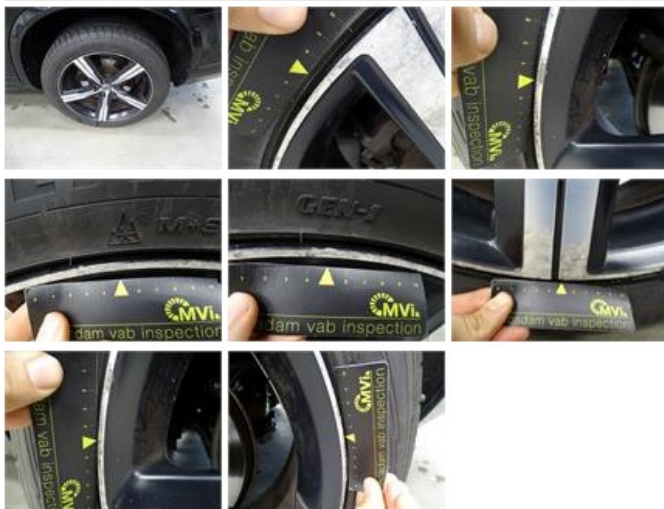
Alloy rim R L polished, Scratch(es), LI - Repair and paint (complete) 95,00

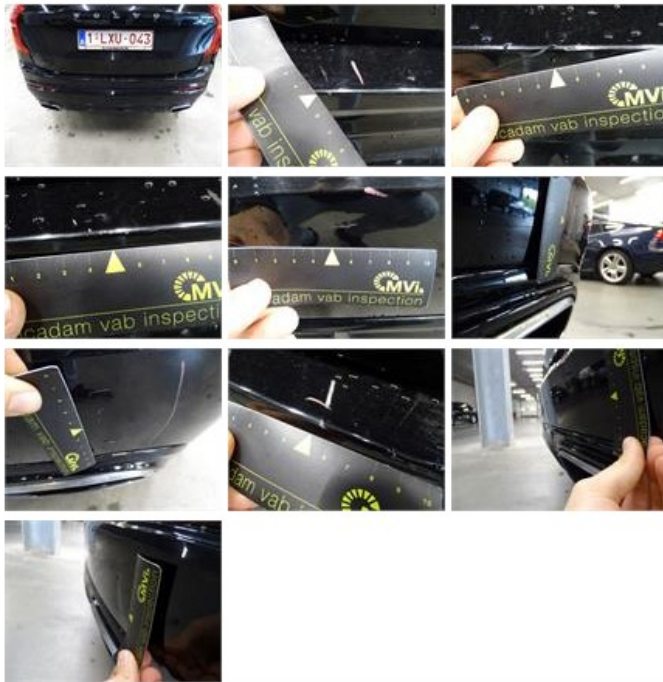
| Bumper R, Dent(s) and scratch(es), LI - Repair and paint (complete) | 254,16 |

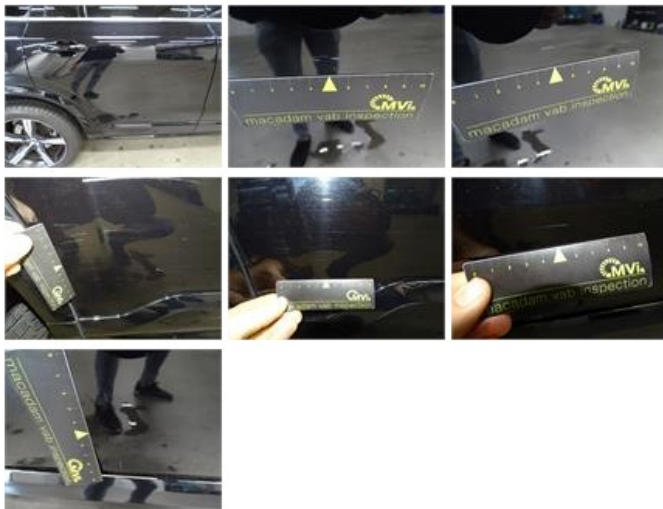
| Door R R, Scratch(es), LI - Repair and paint (complete) | 382,02 |
