## VOLVO V60: 1HPL876

| Vinnumber: | <b>YV1FW8481F1228330</b> | Versionname: | <b>V60 BRE D2 Kinetic 115PK</b> |

## Limited Technical Inspection

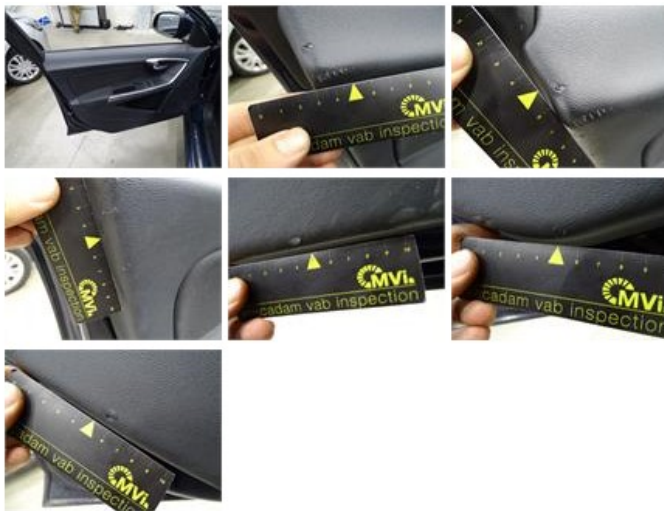
| Door panel F L, Tear, Smart repair | <b>110,64</b> |

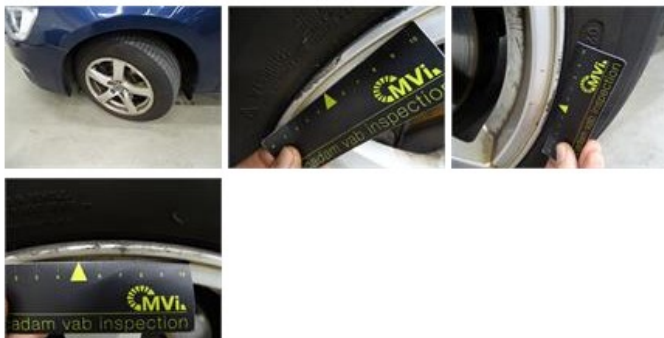
| Alloy rim F L, Scratch(es), LI - Repair and paint (complete) | 95,00 |

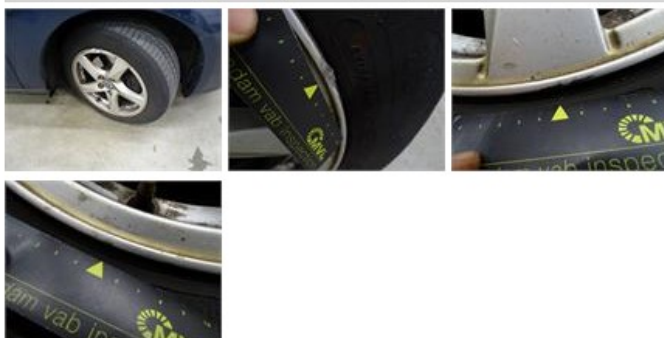
| Alloy rim F R, Scratch(es), LI - Repair and paint (complete) | 95,00 |

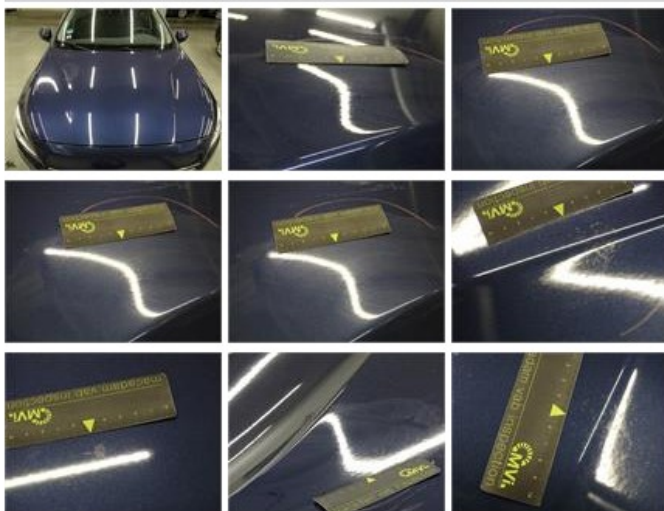
| Bonnet, Chemical polution, LI - Repair and paint (complete) | 290,08 |

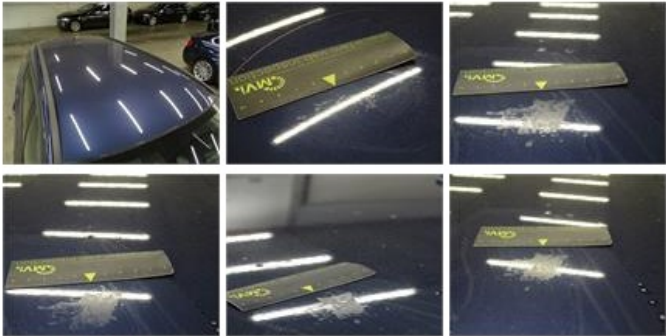
| Roof, Chemical polution, LI - Repair and paint (complete) | | 481,50 |
