## VOLKSWAGEN GOLF VARIANT: 1LDH457

| Vinnumber: | WVWZZZAUZFP600762 | Versionname: | 2.0 CR TDI HIGHLINE |

## Limited Technical Inspection

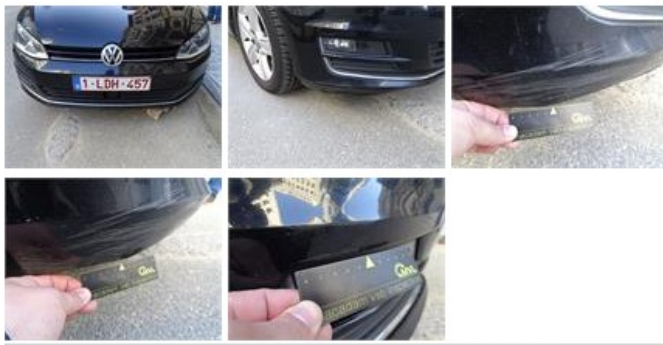
| Bumper F, Dent(s) and scratch(es), LI - Repair and paint (complete) | | | 235,80 |

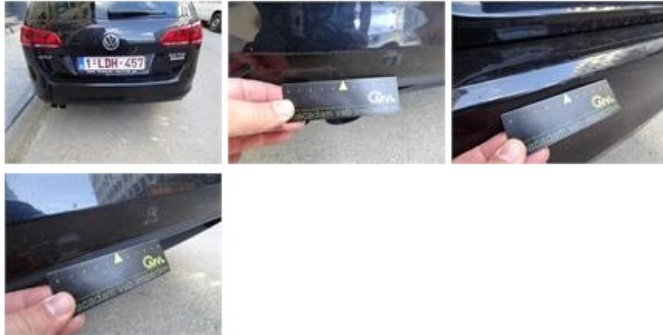
Bumper R, Dent(s) and scratch(es), LI - Repair and paint (complete)

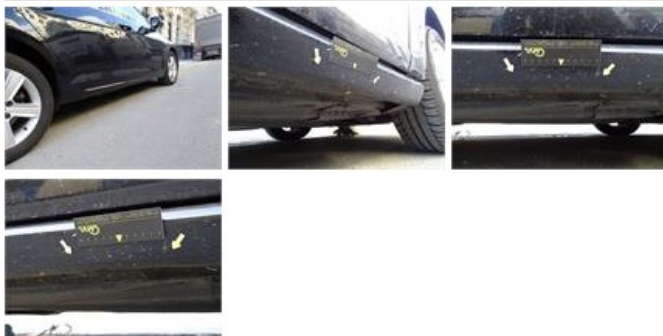
Sill outer R, Dent(s), It - Spot repair

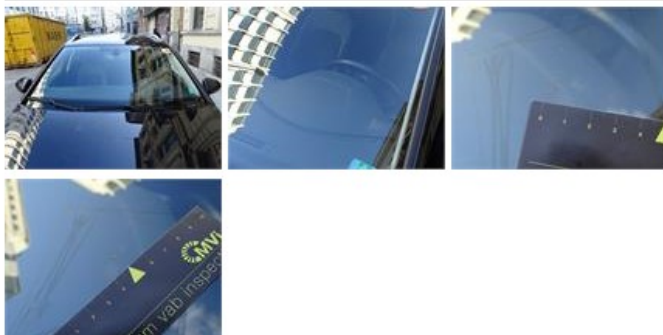
Windscreen, Bad repair, E - Replace
