BMW 3 BERLINE: 1LBR659

Limited Technical Inspection

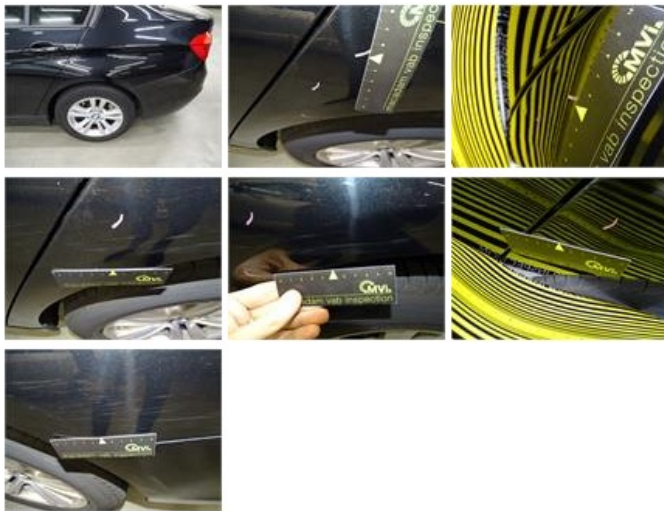
Total cost ex VAT	4108,85
Wing R L, Dent(s) and scratch(es), LI - Repair and paint (complete)	308,20

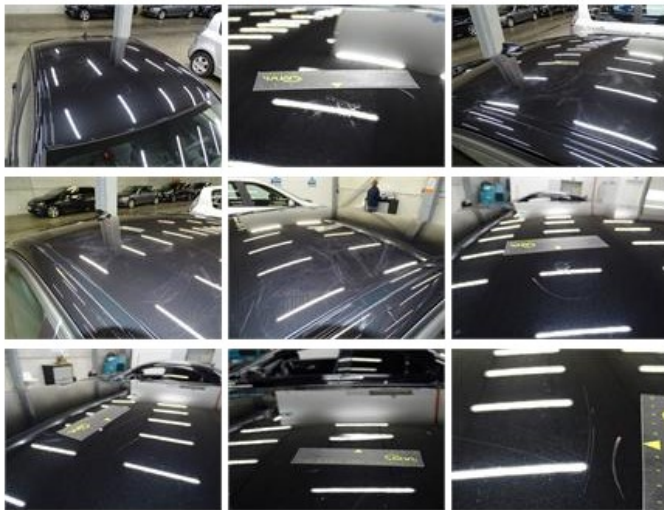
Roof, Chemical polution, LI - Repair and paint (complete)

481,50

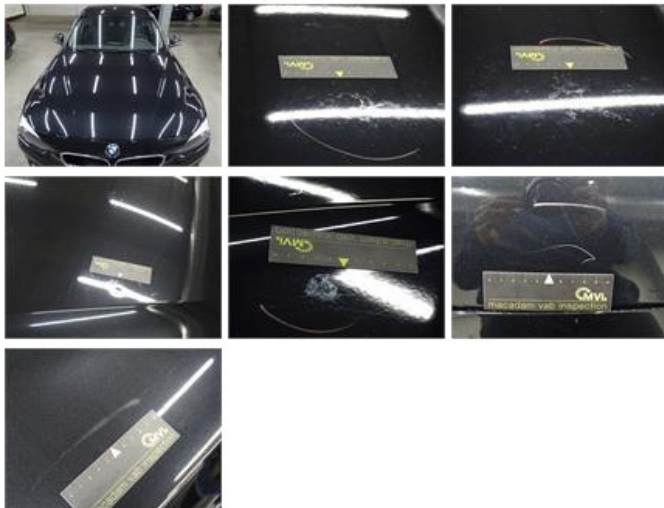
Bonnet, Chemical polution, LI - Repair and paint (complete)

290,08

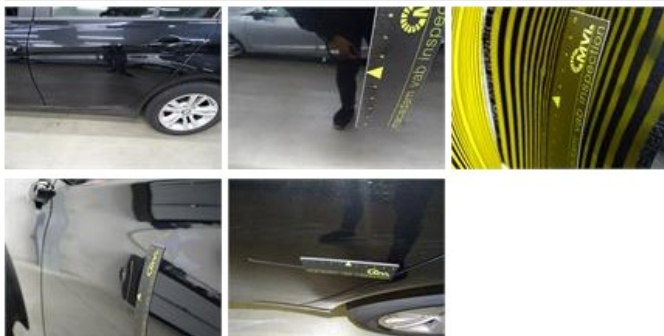
Door R L, Dent(s) and scratch(es), LI - Repair and paint (complete)

318,35

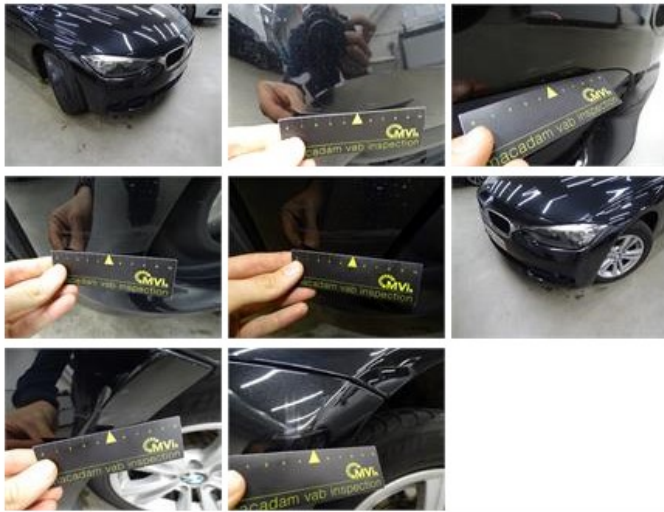
Bumper F, Scratch(es), LI - Repair and paint (complete) 211,80

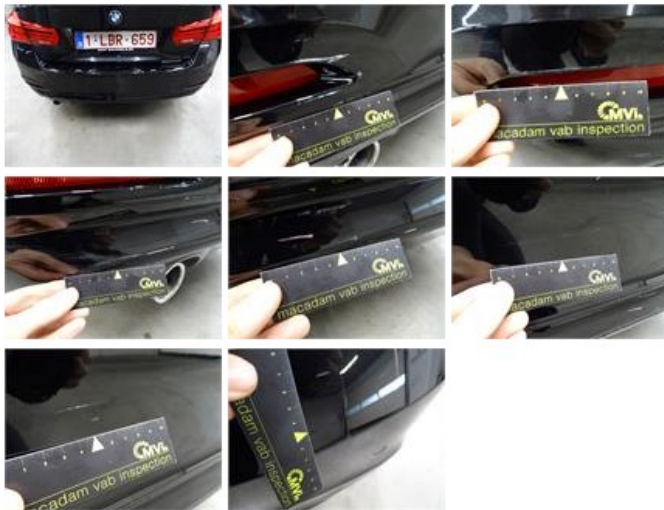
Bumper R, Scratch(es), LI - Repair and paint (complete) 211,80

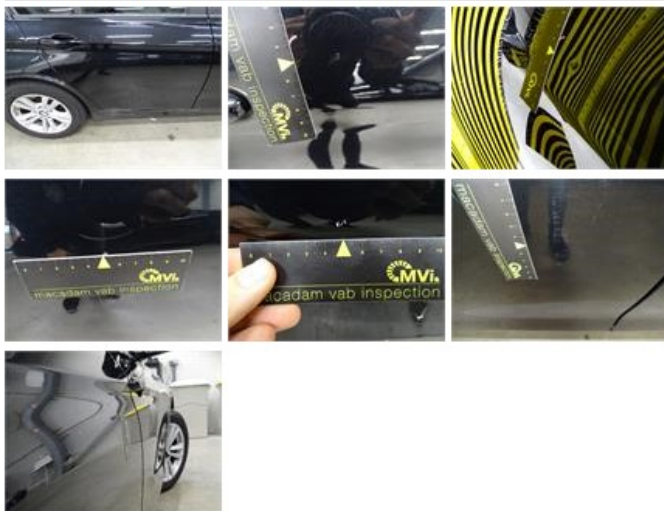
Door R R, Dent(s) and scratch(es), LI - Repair and paint (complete) 318,35

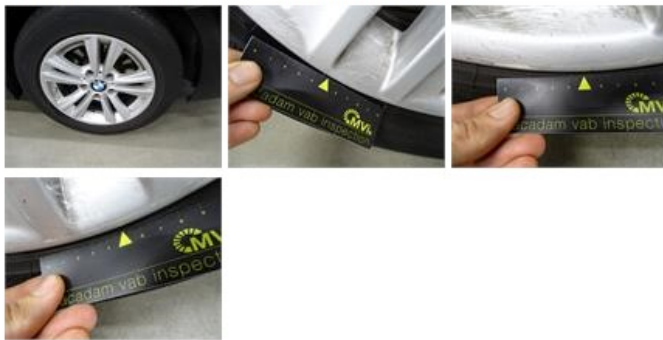
Alloy rim R L, Scratch(es), LI - Repair and paint (complete)

95,00

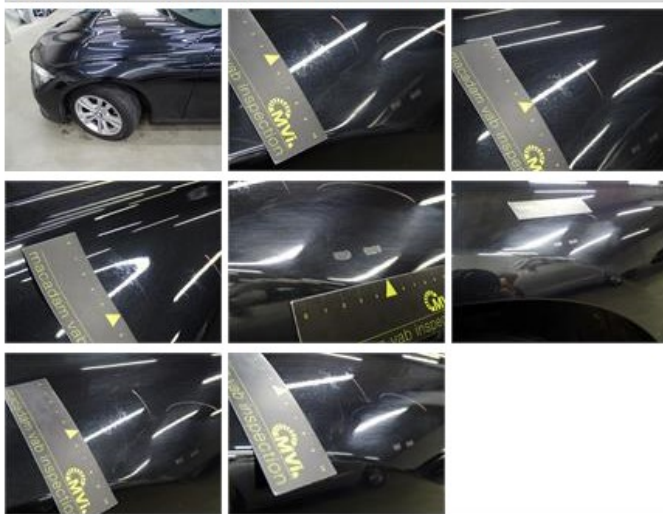
Wing F L, Chemical polution, LI - Repair and paint (complete)

220,18

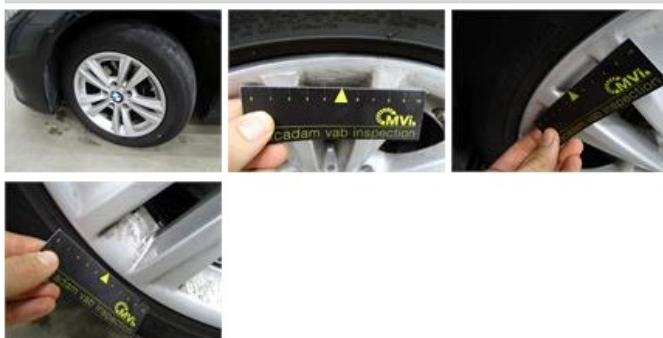
Alloy rim F L, Scratch(es), LI - Repair and paint (complete)

95,00

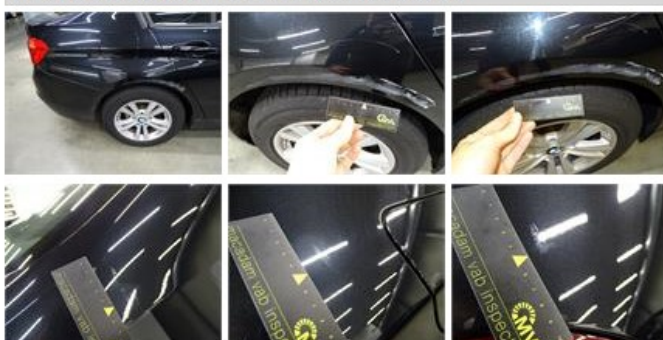
Wing R R, Scratch(es), LI - Repair and paint (complete)

308,20
