**BMW 3 TOURING: 1JLZ353**

Vinnumber:	<b>WBA3K11040K460095</b>	Versionname:	<b>2.0 318D (100KW) TOURING</b>
First Registrationdate:	<b>20/01/2015</b>	Fiscalpower:	
Expertise Mileage:	<b>143099</b>	Power Kw:	<b>100</b>
Bodytype:	<b>Break</b>	Body color:	<b>Grey</b>
Gearbox:	<b>Automatic</b>	Paint type:	<b>Metalic</b>
Transmission:	<b>Back</b>	Rims summer:	<b>Aluminium</b>
Fueltype:	<b>Diesel</b>	Oil level:	<b>OK</b>
Battery functioning:	<b>Yes</b>	Parking lot:	<b>1226</b>
Number of doors:	<b>5</b>		
Number of seats:	<b>5</b>		
Number head rests:	<b>5</b>		
Rims summer:	<b>Aluminium</b>		
Category:	<b>Passenger Car</b>		
Oil level:	<b>OK</b>		
Registration Certificate Car (BE):	<b>Yes</b>

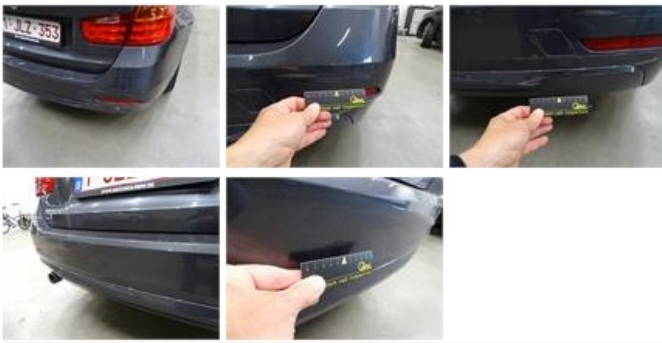
Total cost ex VAT	<b>1080,59</b>
Bumper R, Dent(s) and scratch(es), LI - Repair and paint (complete)	<b>0,00</b>
