BMW 2 ACTIVE TOURER: 1KSJ426

Limited Technical Inspection

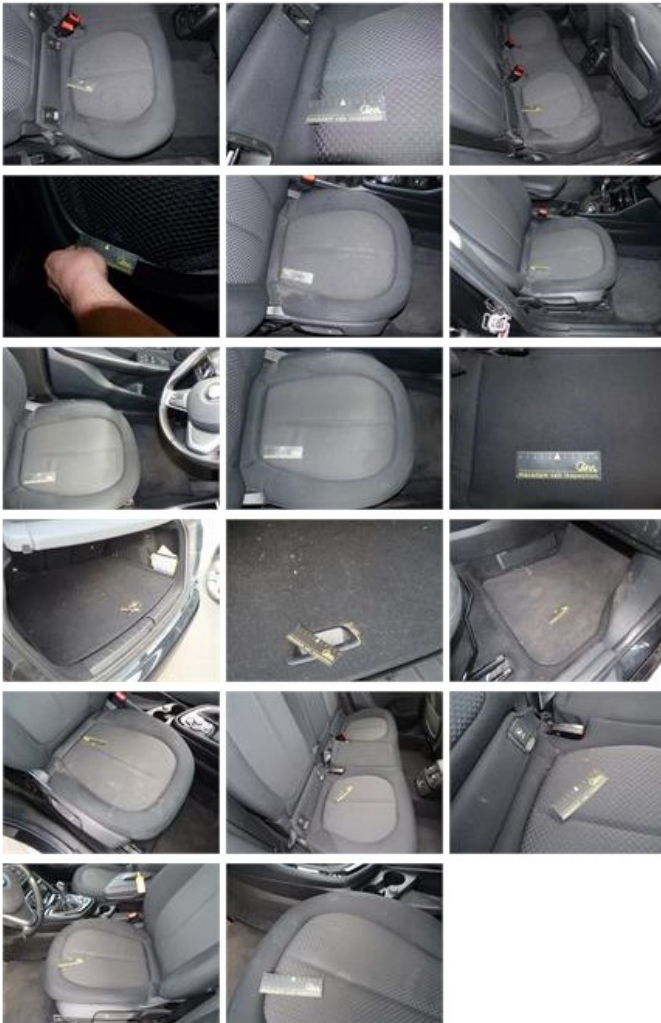
Interior, Dirty, Cleaning 100,00
