**BMW 1: 1GCS826**

**Limited Technical Inspection**

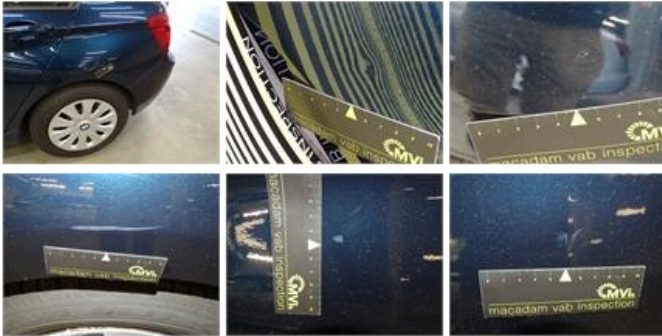
Wing R L, Dent(s) and scratch(es), LI - Repair and paint (complete) 308,20
