**BMW 2 ACTIVE TOURER: 1LSB595**

**Limited Technical Inspection**

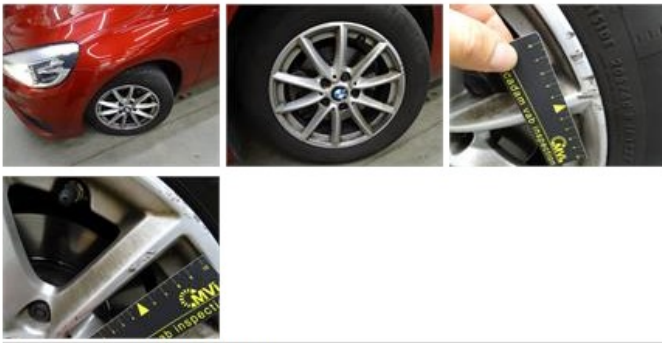
Total cost ex VAT	<b>576,50</b>
Alloy rim R R, Scratch(es), Acceptable	<b>0,00</b>
<i>No pictures to display</i>	
Door R R, Dent(s), Acceptable	<b>0,00</b>
<i>No pictures to display</i>	
Bonnet, Stone chip(s), Acceptable	<b>0,00</b>
<i>No pictures to display</i>	
Alloy rim F L, Scratch(es), LI - Repair and paint (complete)	<b>95,00</b>

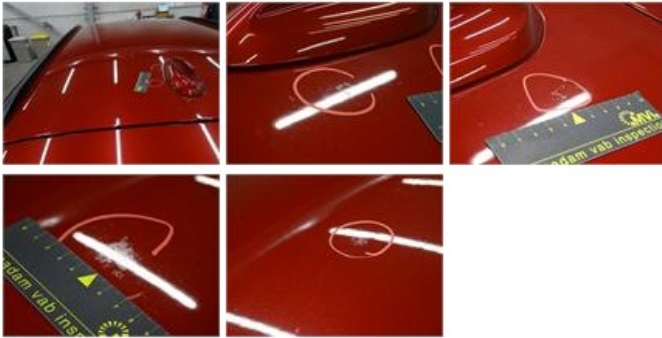
Door R R, Scratch(es), Acceptable	0,00
<i>No pictures to display</i>	
Door F L, Scratch(es), Acceptable	0,00
<i>No pictures to display</i>	
Wing R L, Scratch(es), Acceptable	0,00
<i>No pictures to display</i>	
Wing F R, Scratch(es), Acceptable	0,00
<i>No pictures to display</i>	
Bumper R, Scratch(es), Acceptable	0,00
<i>No pictures to display</i>	
Alloy rim F R, Scratch(es), Acceptable	0,00
<i>No pictures to display</i>	
Wing R R, Scratch(es), Acceptable	0,00
<i>No pictures to display</i>	
Roof, Chemical polution, LI - Repair and paint (complete)	481,50
