MERCEDES A: 1HLL227

Limited Technical Inspection

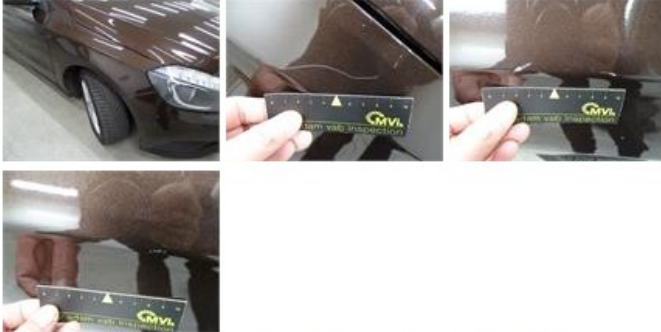
Wing F R, Scratch(es), LI - Repair and paint (complete) 220,18

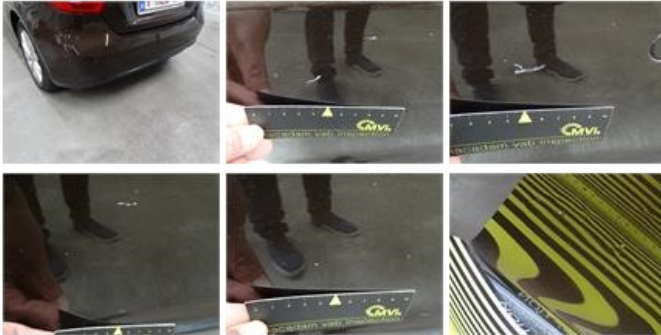
Bumper R, Dent(s) and scratch(es), LI - Repair and paint (complete) 211,80
