**FORD FIESTA: 1UFV100**

**Limited Technical Inspection**

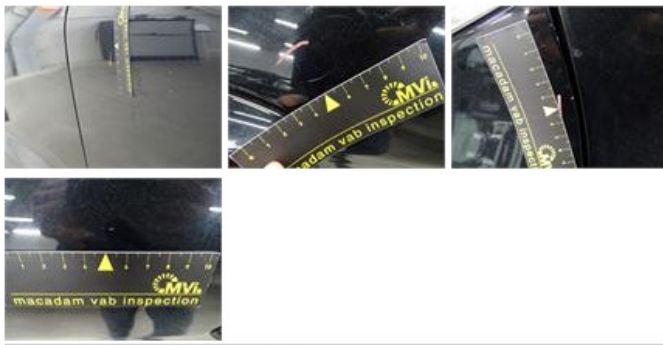
<b>Total cost ex VAT</b>	<b>496,02</b>
<b>Door R L, Dent(s) and scratch(es), LI - Repair and paint (complete)</b>	<b>254,68</b>

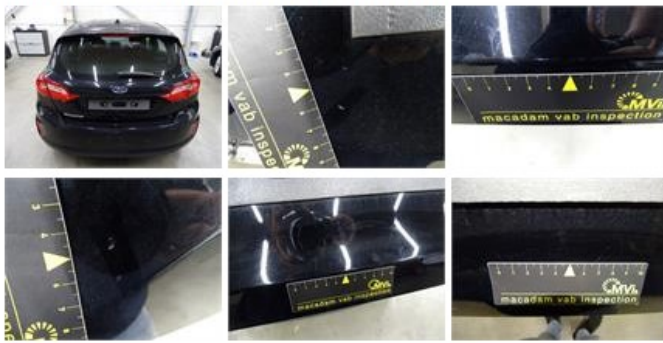
Bumper R, Scratch(es), Acceptable	0,00
<i>No pictures to display</i>	
Door panel F L, Scratch(es), Acceptable	0,00
<i>No pictures to display</i>	
Door panel R R, Scratch(es), Acceptable	0,00
<i>No pictures to display</i>	
Tailgate, Scratch(es), LI - Repair and paint (complete)	241,34
