BMW X3: 1FIK701

Limited Technical Inspection

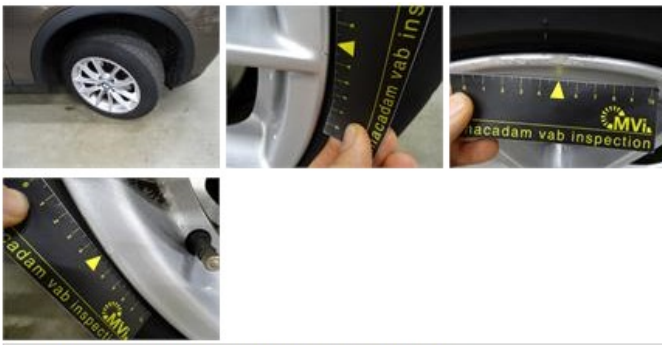
Total cost ex VAT	2953,10
Alloy rim F R, Scratch(es), LI - Repair and paint (complete)	95,00

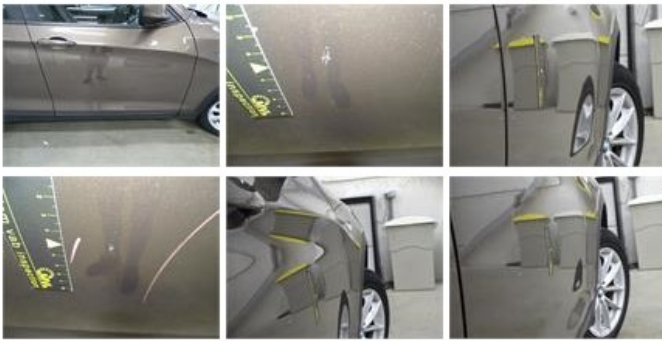
Door F R, Dent(s) and scratch(es), LI - Repair and paint (complete) 382,02

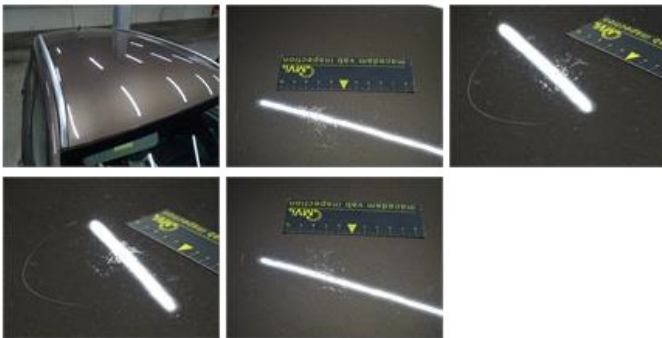
Roof, Chemical polution, LI - Repair and paint (complete) 577,80

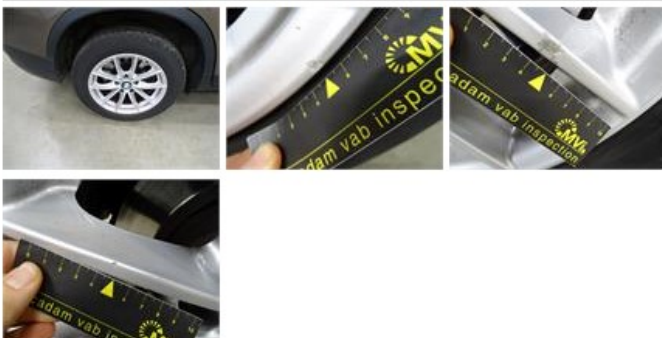
Alloy rim R R, Scratch(es), LI - Repair and paint (complete) 95,00

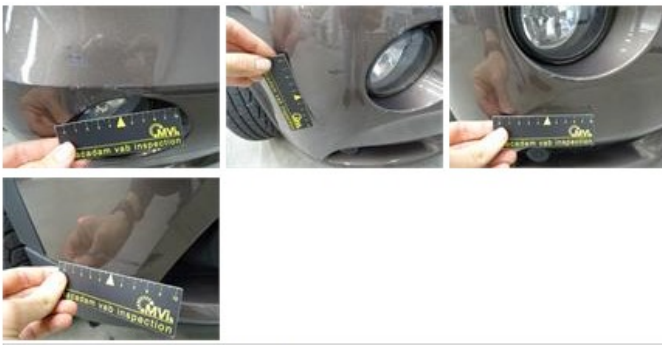
Bumper F, Scratch(es), LI - Repair and paint (complete) 254,16

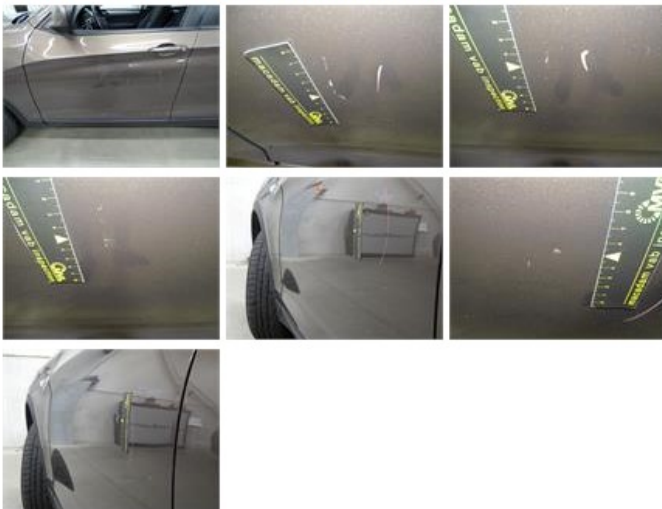
Door F L, Dent(s) and scratch(es), LI - Repair and paint (complete) 382,02

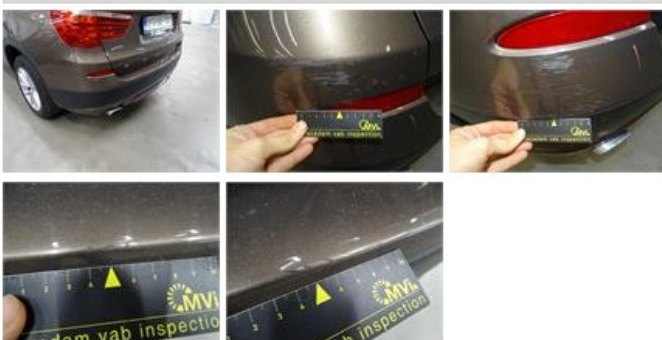
Bumper R, Scratch(es), LI - Repair and paint (complete) 254,16

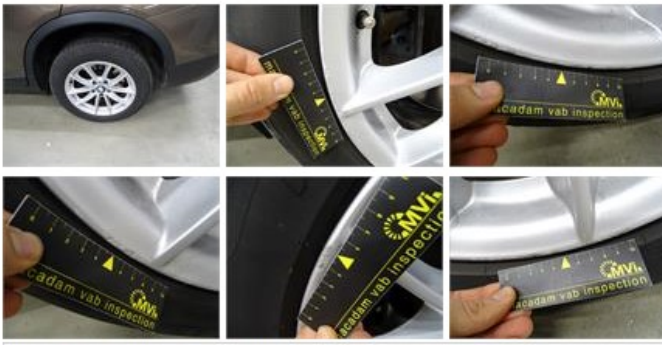
Alloy rim R L, Scratch(es), LI - Repair and paint (complete) 95,00

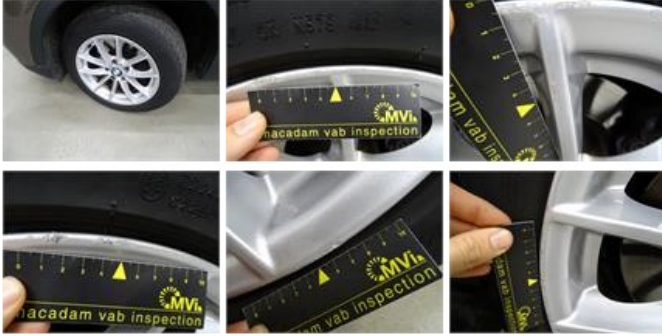
Alloy rim F L, Scratch(es), LI - Repair and paint (complete) 95,00
