PEUGEOT 308: 1HEY110

Vinnumber:	VF3LCBHXHES156529	Versionname:	308 SW BlueHDi Active STT 116PK
First Registrationdate:	3/07/2014	Fiscalpower:	
Expertise Mileage:	99705	Power Kw:	85
Bodytype:		Body color:	Grey
Gearbox:	MAN 6 VIT	Paint type:	Metalic
Transmission:	Front	Rims summer:	Aluminium
Fueltype:	Diesel	Oil level:	OK
Battery functioning:	Yes	Parking lot:	3509
Number of doors:	5		
Number of seats:	5		
Number head rests:	5		
Rims summer:	Aluminium		
Category:	Passenger Car		
Oil level:	OK		
Registration Certificate Car (BE):	Yes

Limited Technical Inspection

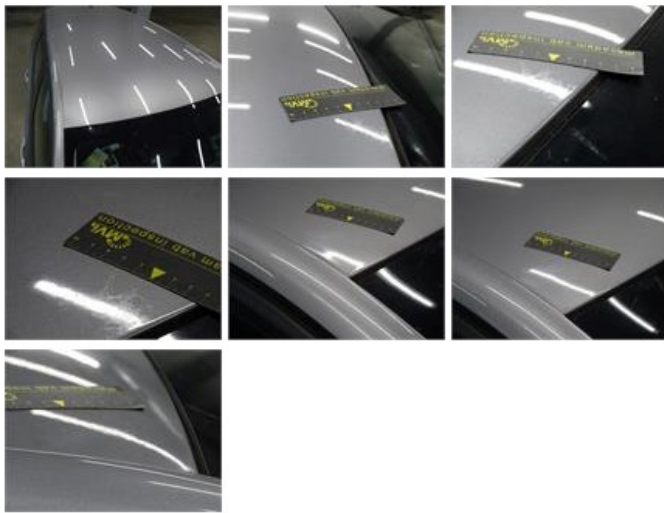
Total cost ex VAT	1593,30
Roof, Chemical polution, LI - Repair and paint (complete)	481,50

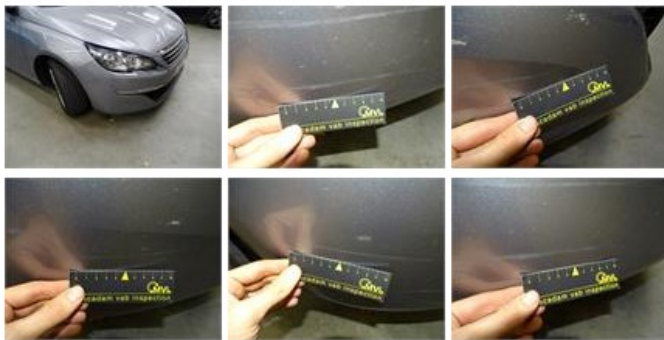
Bumper F, Scratch(es), LI - Repair and paint (complete) 211,80

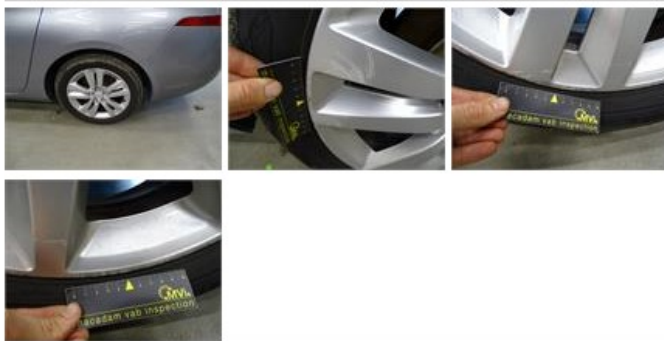
Alloy rim R L, Scratch(es), LI - Repair and paint (complete) 95,00

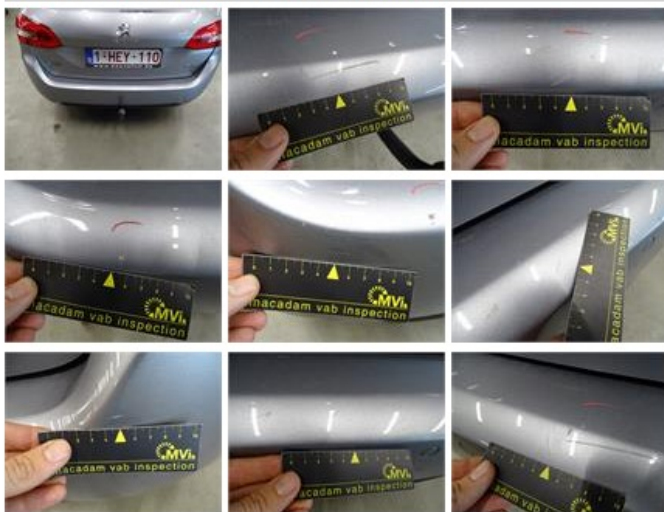
Bumper R, Scratch(es), LI - Repair and paint (complete) 211,80
