**VOLKSWAGEN Golf: 1HUH582**

**Limited Technical Inspection**

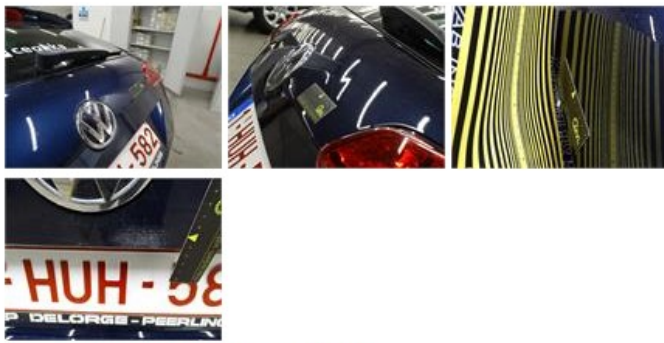
Total cost ex VAT	821,68
Tailgate, Dent(s) and scratch(es), LI - Repair and paint (complete)	301,68
