VOLVO V40: 1KAN023

Limited Technical Inspection

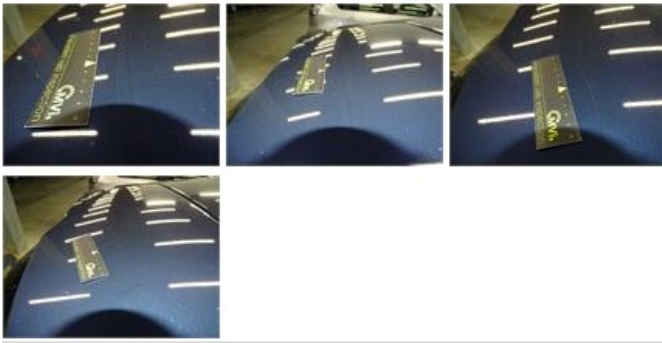
Rear spoiler, Scratch(es), LI - Repair and paint (complete) 115,56
