VOLVO V60: 1RAE179

Limited Technical Inspection

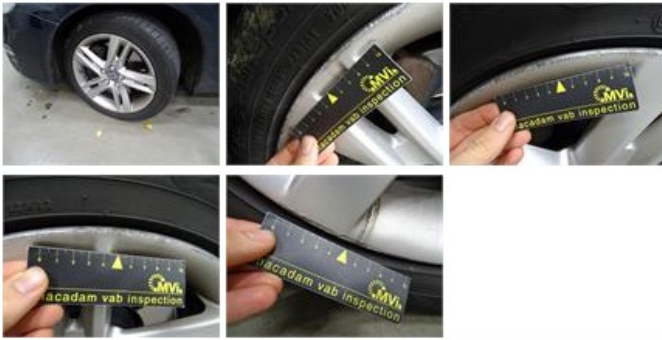
Alloy rim F L, Scratch(es), LI - Repair and paint (complete) 0,00

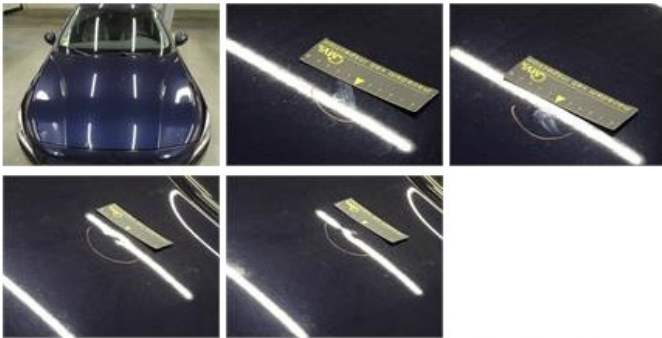
Bonnet, Chemical pollution, LI - Repair and paint (complete) 0,00

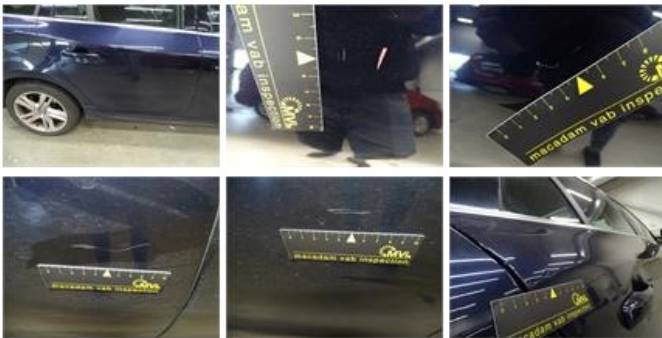
Door R R, Dent(s) and scratch(es), LI - Repair and paint (complete) 0,00

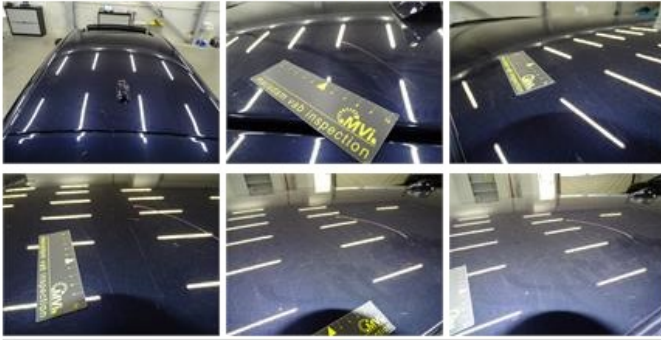
Roof, Scratch(es), LI - Repair and paint (complete)

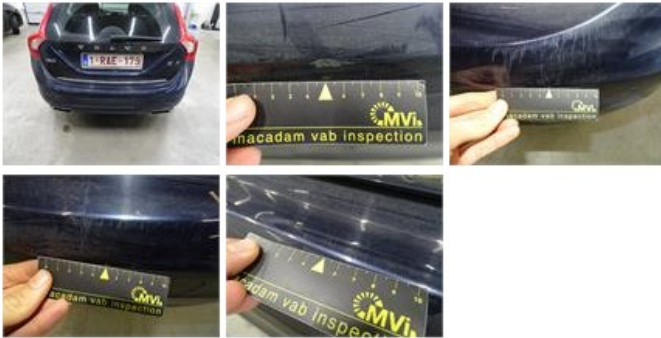
Bumper R, Scratch(es), LI - Repair and paint (partial)

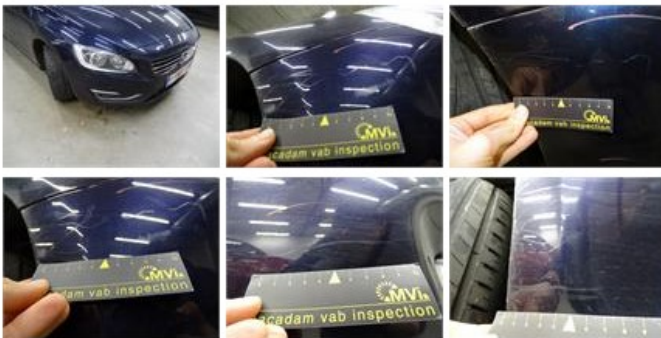
Bumper F, Scratch(es), LI - Repair and paint (complete)
