**VOLVO XC60: 1HRN635**

**Limited Technical Inspection**

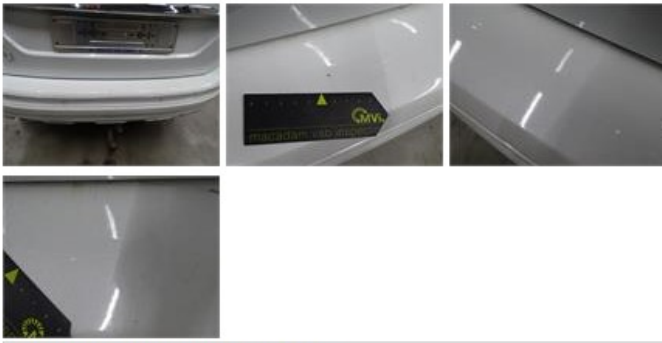
Repair kit	<b>Yes</b>	Compressor	<b>Yes</b>
Total cost ex VAT			<b>1749,78</b>
Bumper R, Scratch(es), Le - Replace and paint			<b>766,80</b>
