BMW 2 ACTIVE TOURER: SJ5298

Limited Technical Inspection

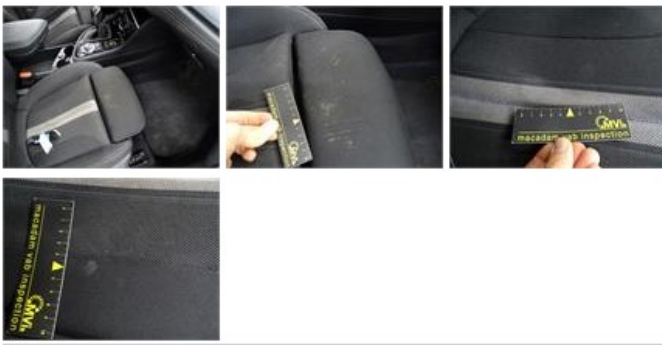
Total cost ex VAT	661,70
Bumper F, Scratch(es), Acceptable	0,00
<i>No pictures to display</i>	
Seat cover F R, Dirty, Cleaning	25,00

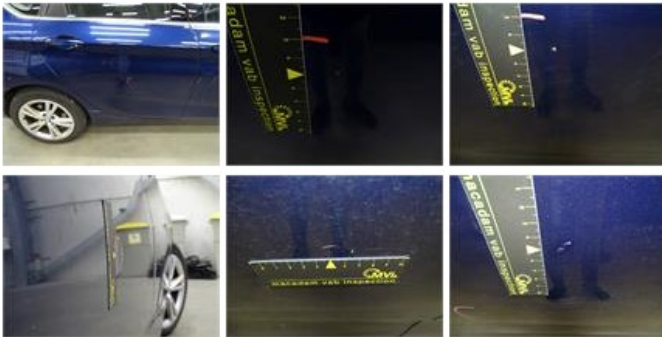
Door R R, Dent(s) and scratch(es), LI - Repair and paint (complete) 318,35

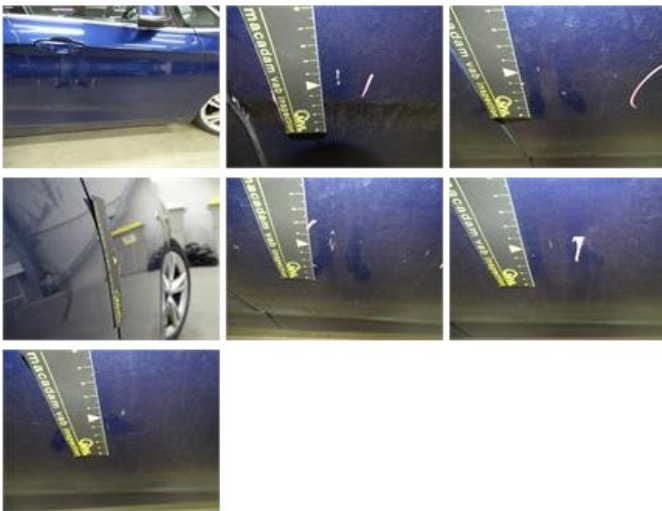
Door F R, Dent(s) and scratch(es), LI - Repair and paint (complete) 318,35
