SEAT ALHAMBRA: 1KRD762

Limited Technical Inspection

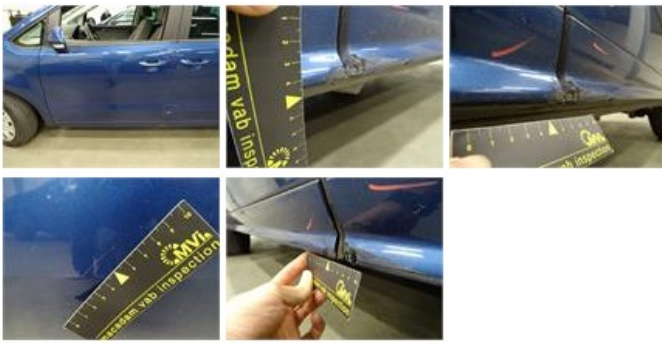
Total cost ex VAT	3322,32
Door F L, Dent(s) and scratch(es), LI - Repair and paint (complete)	382,02

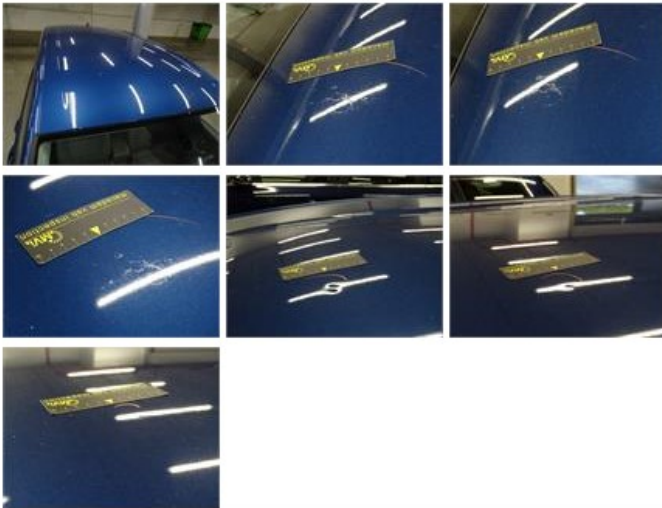
Roof, Chemical polution, LI - Repair and paint (complete) 577,80

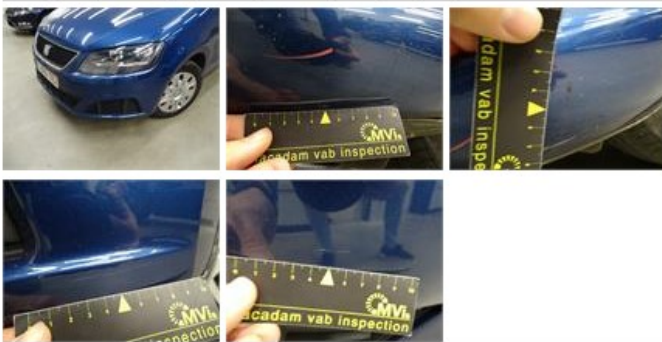
Bumper F, Scratch(es), LI - Repair and paint (complete) 254,16

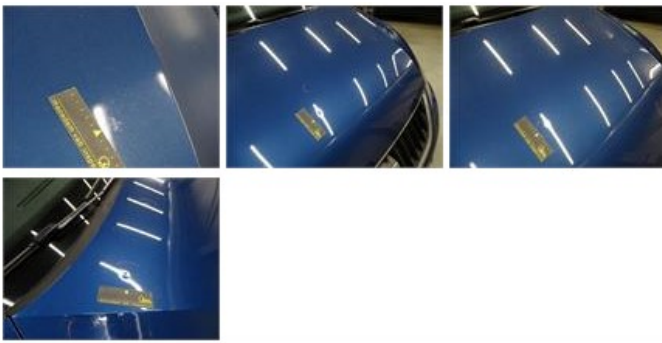
Bonnet, Chemical polution, LI - Repair and paint (complete) 348,09

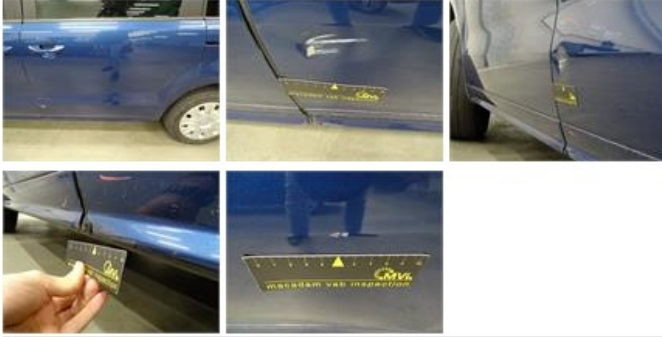
Door R L, Dent(s) and scratch(es), LI - Repair and paint (complete) 382,02

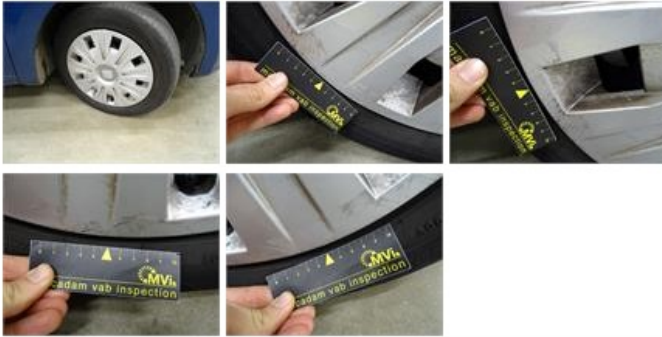
Wheel cover F R, Scratch(es), E - Replace 36,00

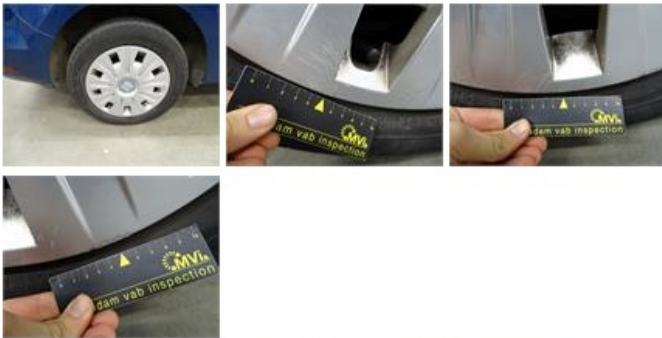
Wheel cover R R, Scratch(es), E - Replace 36,00

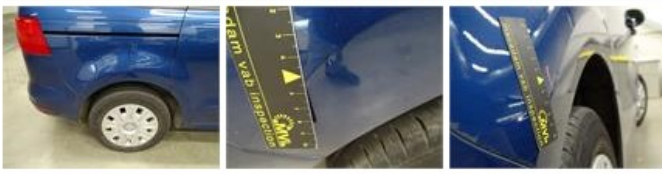
Wing R R, Dent(s) and scratch(es), LI - Repair and paint (complete) 369,84
