PEUGEOT 3008: 1KR719

Limited Technical Inspection

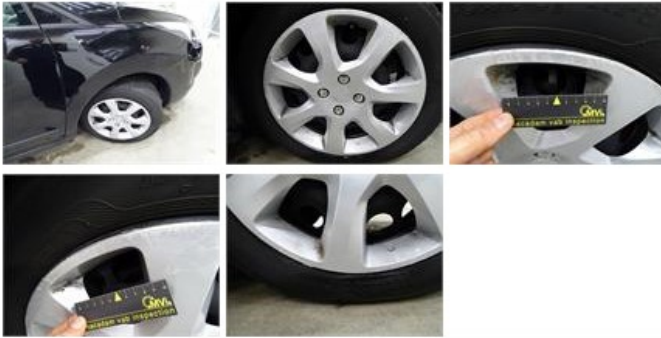
Wheel cover F R, Scratch(es), E - Replace

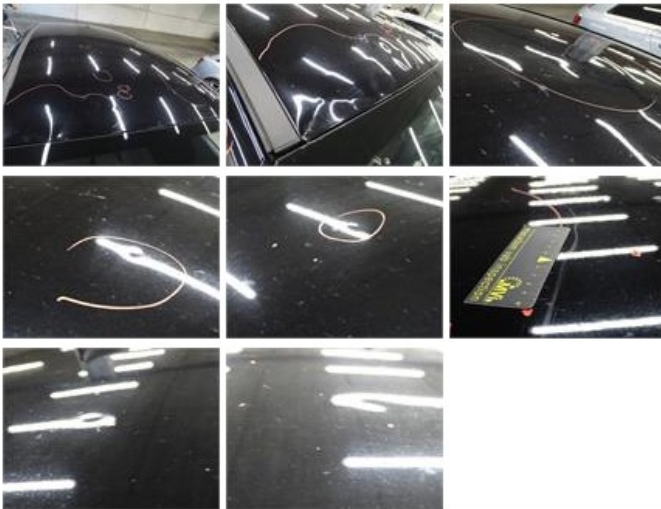
Roof, Dent(s) and scratch(es), LI - Repair and paint (complete)

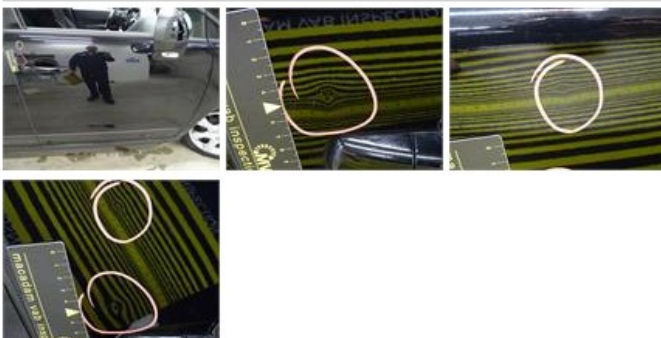
Door F R, Dent(s), PDR - Paintless dent repair

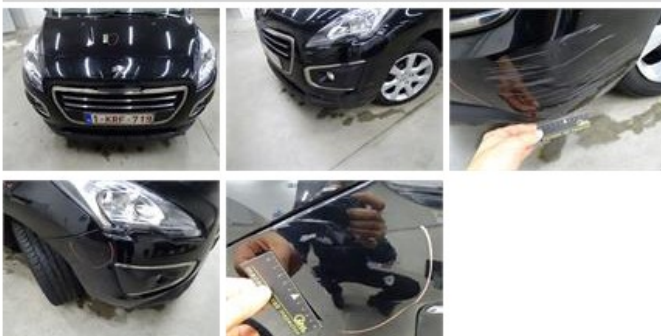
Bumper F, Scratch(es), LI - Repair and paint (complete)
