MINI : 1PEN956

Limited Technical Inspection

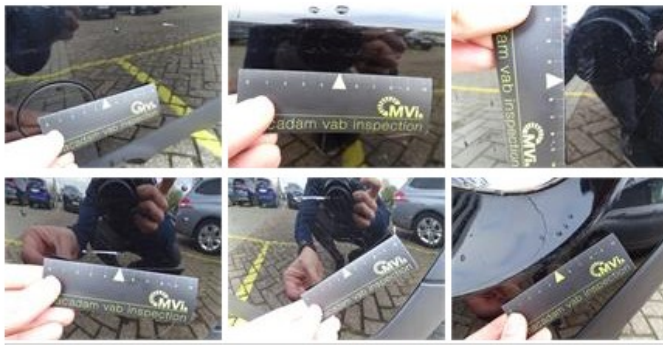
Bonnet, Dent(s) and scratch(es), LI - Repair and paint (complete)

290,08

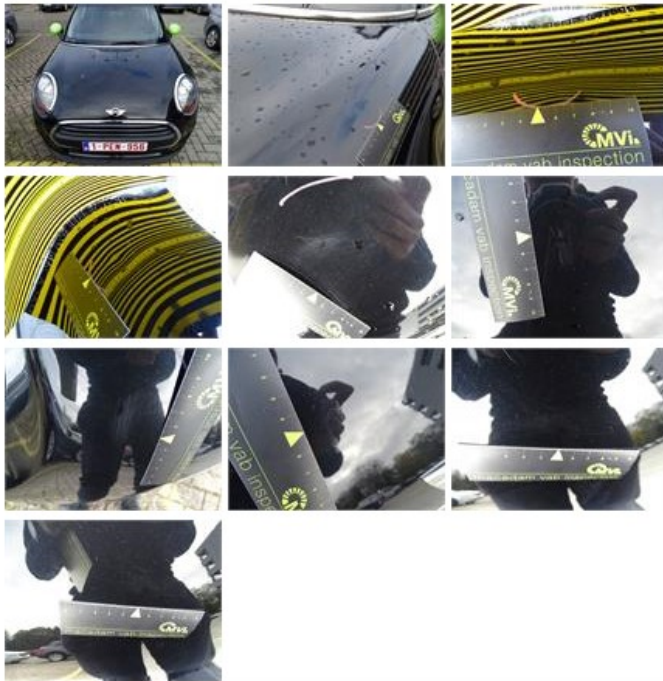
Bumper F, Scratch(es), Acceptable

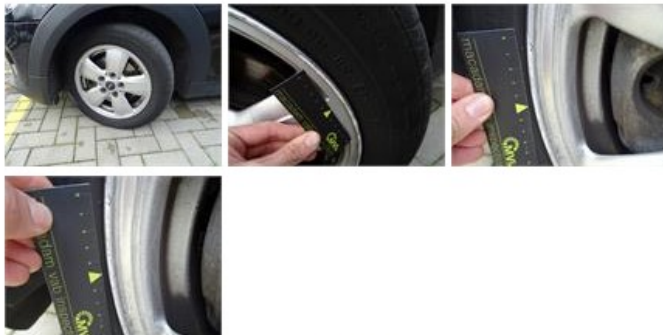
Wheel hub cap F L, Not original part, Acceptable

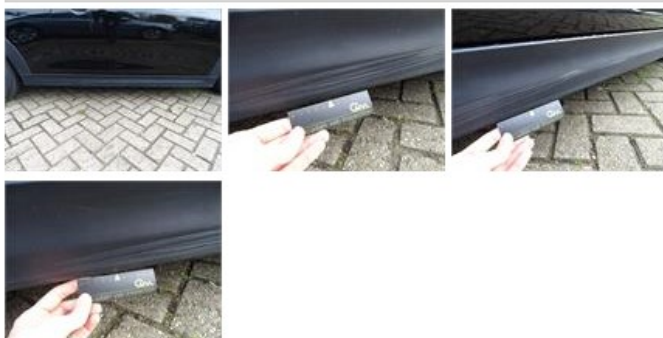
Wing trim R L, Scratch(es), Acceptable
