VOLKSWAGEN GOLF VARIANT: 1LDA151

| Vinnumber: | WVWZZZAUZFP591374 | Versionname: | 1.6 CR TDI TRENDLINE |

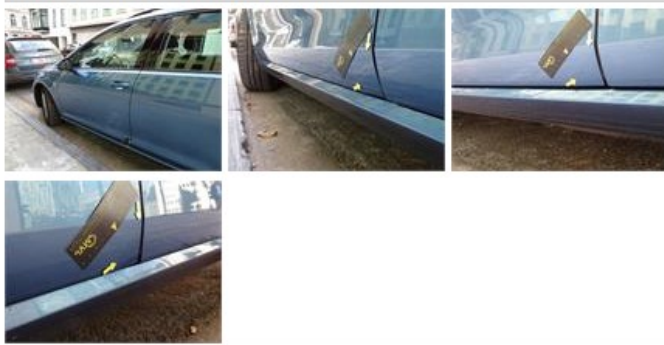
| Door F L, Dent(s), PDR - Paintless dent repair | 63,00 |

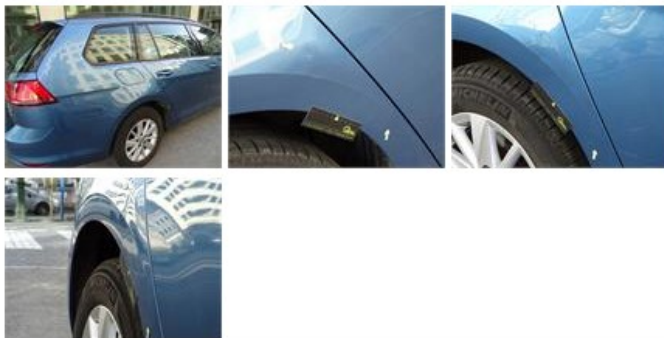
Wing R R, Dent(s) and scratch(es), LI - Repair and paint (complete)

404,20

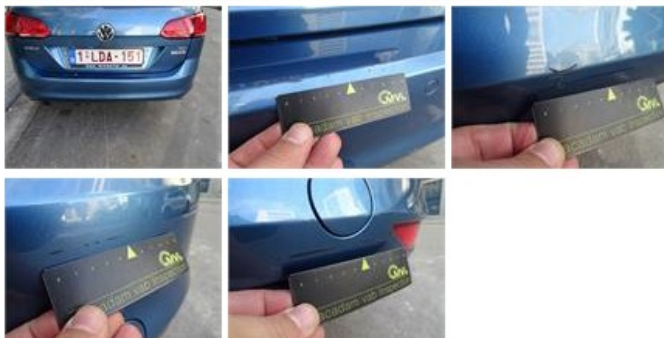
Bumper R, Scratch(es), LI - Repair and paint (complete)

211,80
