VOLKSWAGEN POLO: 1KST063

Limited Technical Inspection

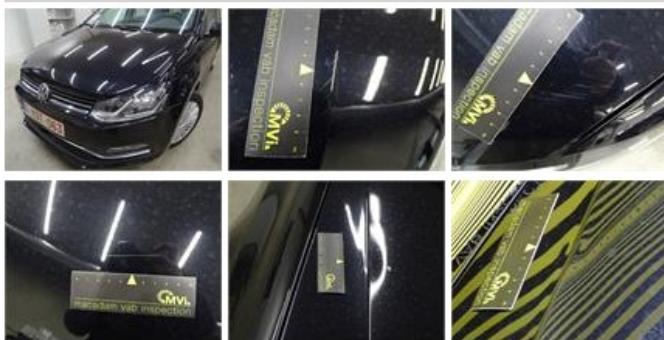
Bonnet, Dent(s) and scratch(es), LI - Repair and paint (complete)

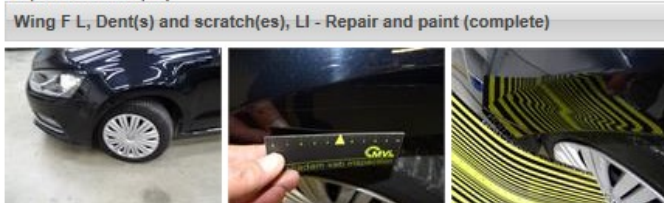
Wing F L, Dent(s) and scratch(es), LI - Repair and paint (complete)
