**CITROEN DS5: 1GCR988**

**Limited Technical Inspection**

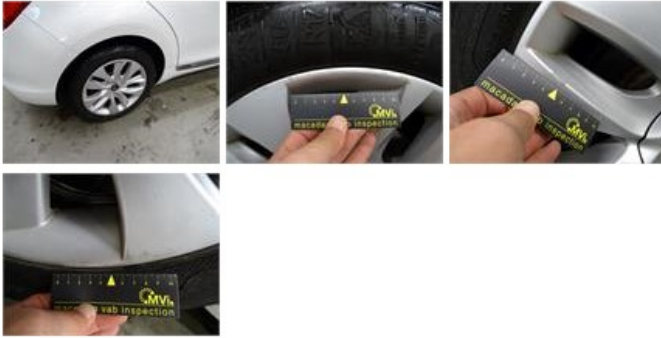
Alloy rim R R, Scratch(es), I - Repair

50,00
