BMW 5 TOURING: 1LRF087

Vinnumber:	WBA5L31080G084912	Versionname:	2.0 520D (120KW) TOURING
First Registrationdate:	13/11/2015	Fiscalpower:	
Expertise Mileage:	157724	Power Kw:	120
Bodytype:		Body color:	Silver
Gearbox:	Automatic	Paint type:	Metalic
Transmission:	Back	Rims summer:	Aluminium
Fueltype:	Diesel	Oil level:	OK
Battery functioning:	Yes	Parking lot:	2716
Number of doors:	5		
Number of seats:	5		
Number head rests:	5		
Rims summer:	Aluminium		
Category:	Passenger Car		
Oil level:	OK		
Registration Certificate Car (BE):	Yes

Limited Technical Inspection

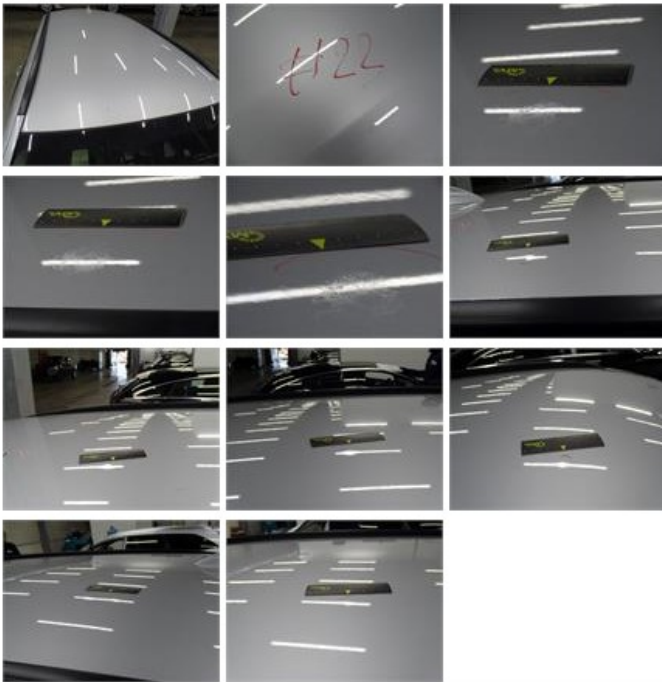
Roof, Chemical polution, LI - Repair and paint (complete) 697,80

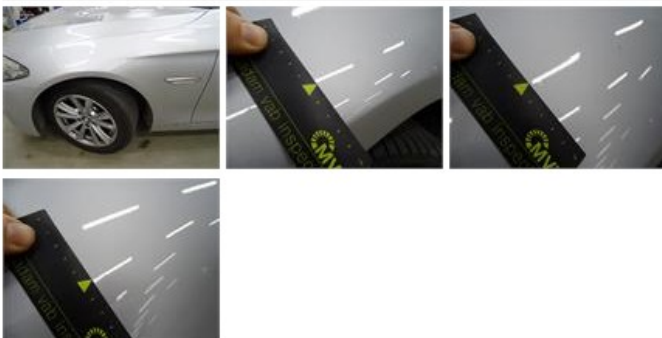
Wing F L, Bad repair, Acceptable 0,00

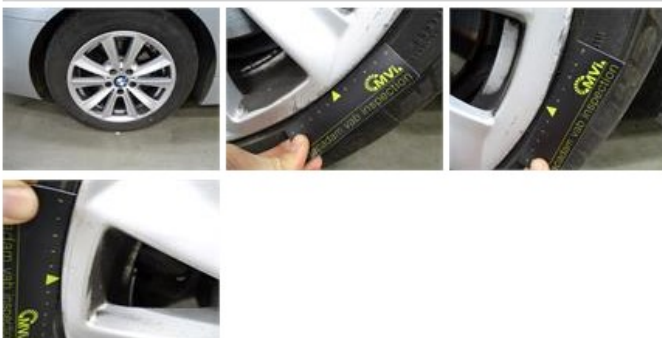
Alloy rim R R, Scratch(es), LI - Repair and paint (complete) 95,00

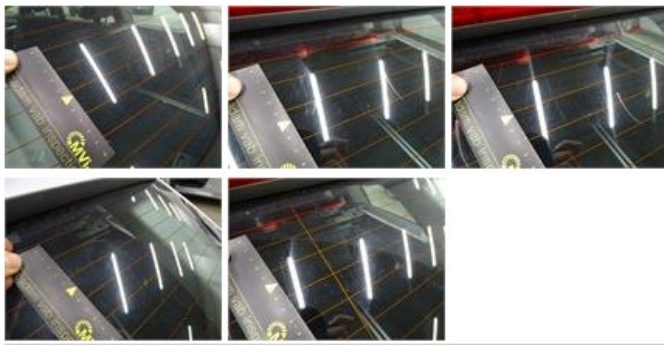
Rear window, Scratch(es), E - Replace 0,00

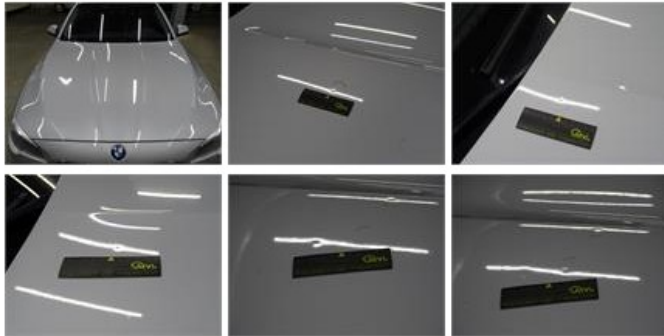
Bonnet, Dent(s), PDR - Paintless dent repair 241,20

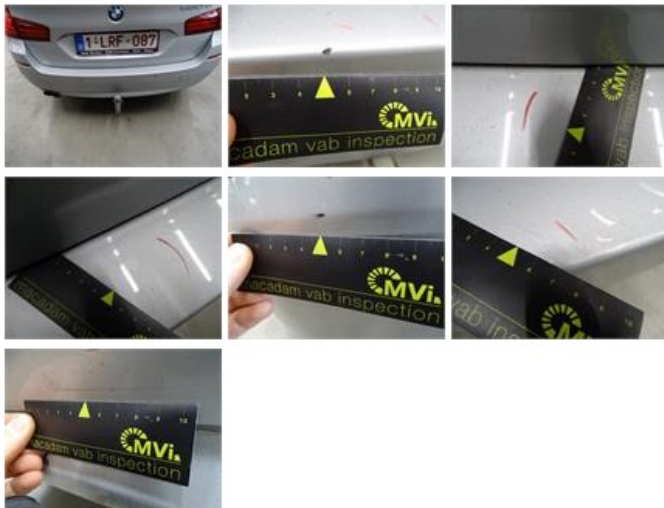
Bumper R, Scratch(es), LI - Repair and paint (complete) 254,16
