<b>BMW X3: 1LGY256</b>			
Vinnumber:	<b>WBAWZ310500K96212</b>	Versionname:	<b>2.0 SDRIVE18D (100KW)</b>
First Registrationdate:	<b>25/09/2015</b>	Fiscalpower:	
Expertise Mileage:	<b>69514</b>	Power Kw:	<b>100</b>
Bodytype:		Body color:	<b>Black</b>
Gearbox:	<b>Automatic</b>	Paint type:	<b>Metalic</b>
Transmission:	<b>Back</b>	Rims summer:	<b>Aluminium</b>
Fueltype:	<b>Diesel</b>	Oil level:	<b>OK</b>
Battery functioning:	<b>Yes</b>	Parking lot:	<b>3310</b>
Number of doors:	<b>5</b>		
Number of seats:	<b>5</b>		
Number head rests:	<b>5</b>		
Rims summer:	<b>Aluminium</b>		
Category:	<b>Passenger Car</b>		
Oil level:	<b>OK</b>		
Registration Certificate Car (BE):	<b>Yes</b>

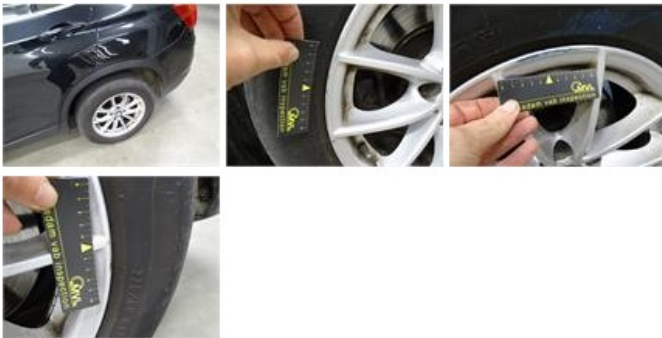
Alloy rim R L, Scratch(es), LI - Repair and paint (complete)

95,00

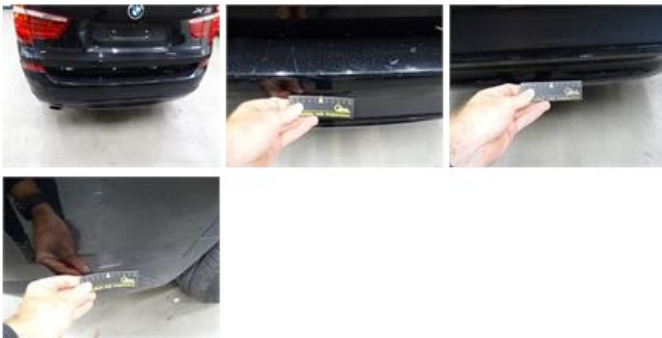
Bumper R, Scratch(es), LI - Repair and paint (complete)

254,16
